**North Campus Open Space Restoration Project  
As-Built Grading and Hydrology Report**

**July 2018**

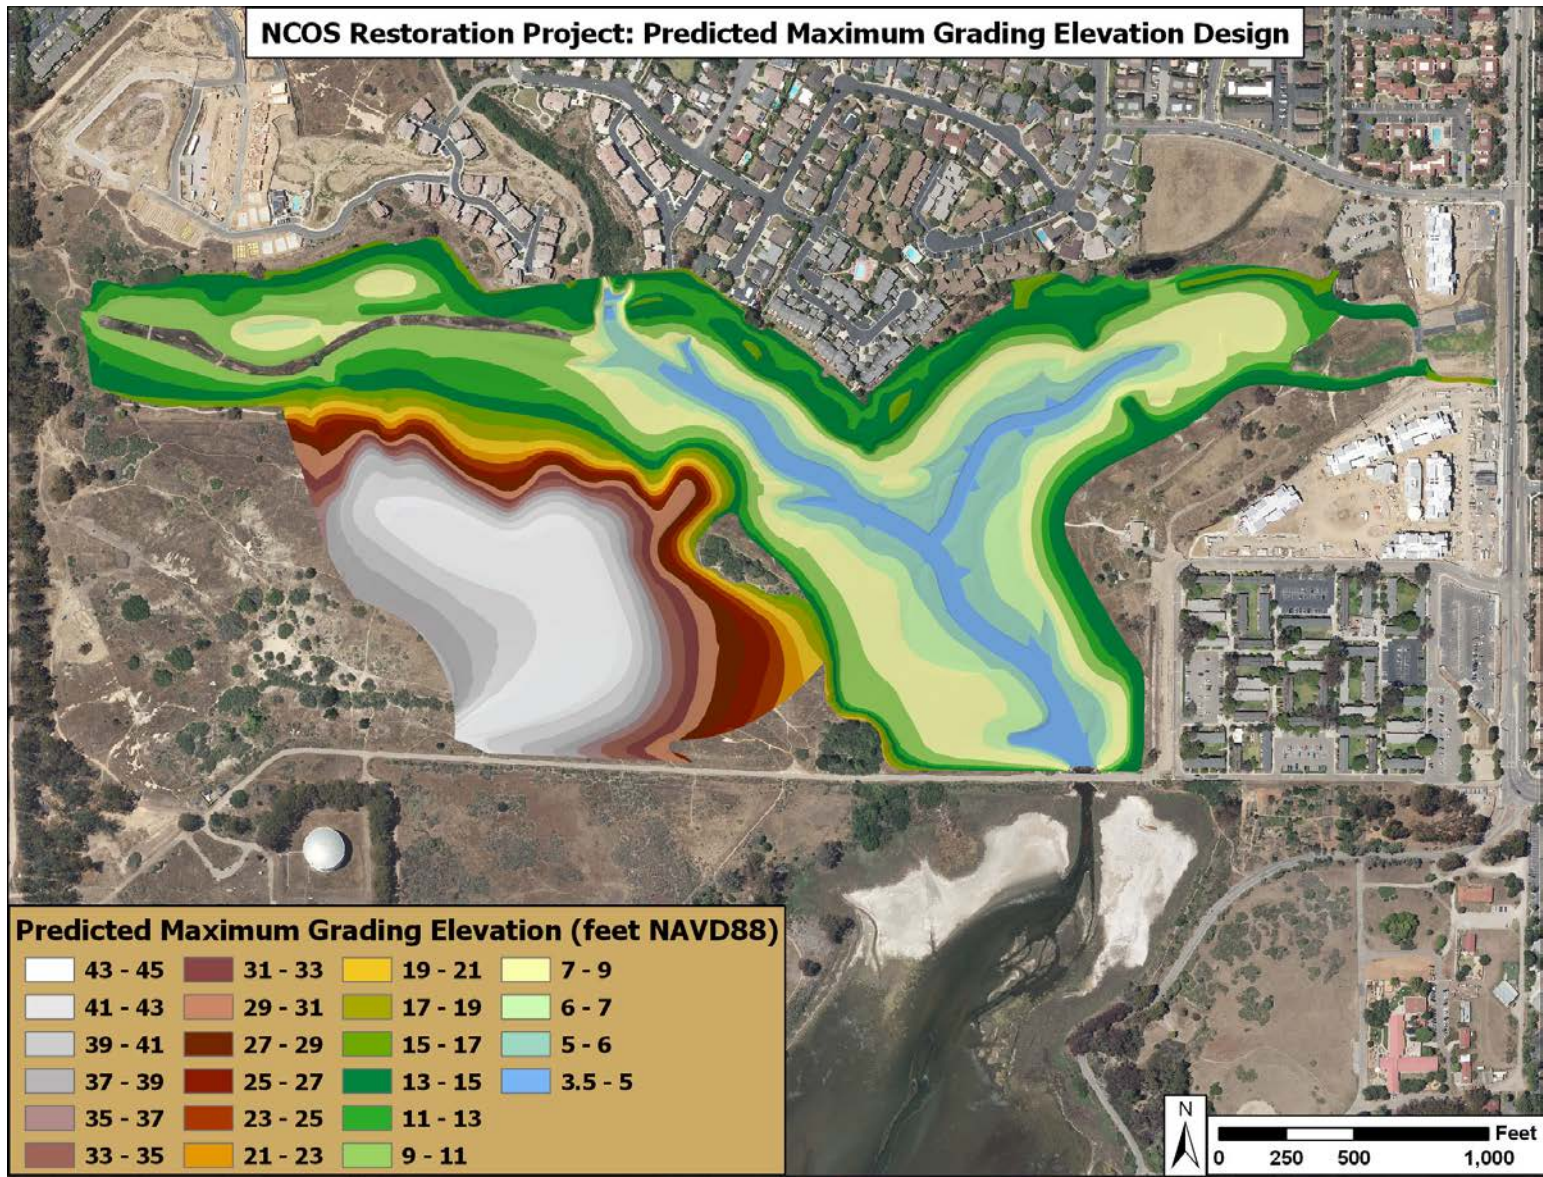
Figure 1. Map showing a representation of the predicted maximum grading elevation design for the NCOS Restoration Project.

The grading portion of the NCOS restoration project was completed in October 2017, and an as-built digital elevation model (DEM) of the final grading was produced in early November 2017. Maps showing representations of the designed and final as-built grading elevations are provided in Figures 1 and 2.

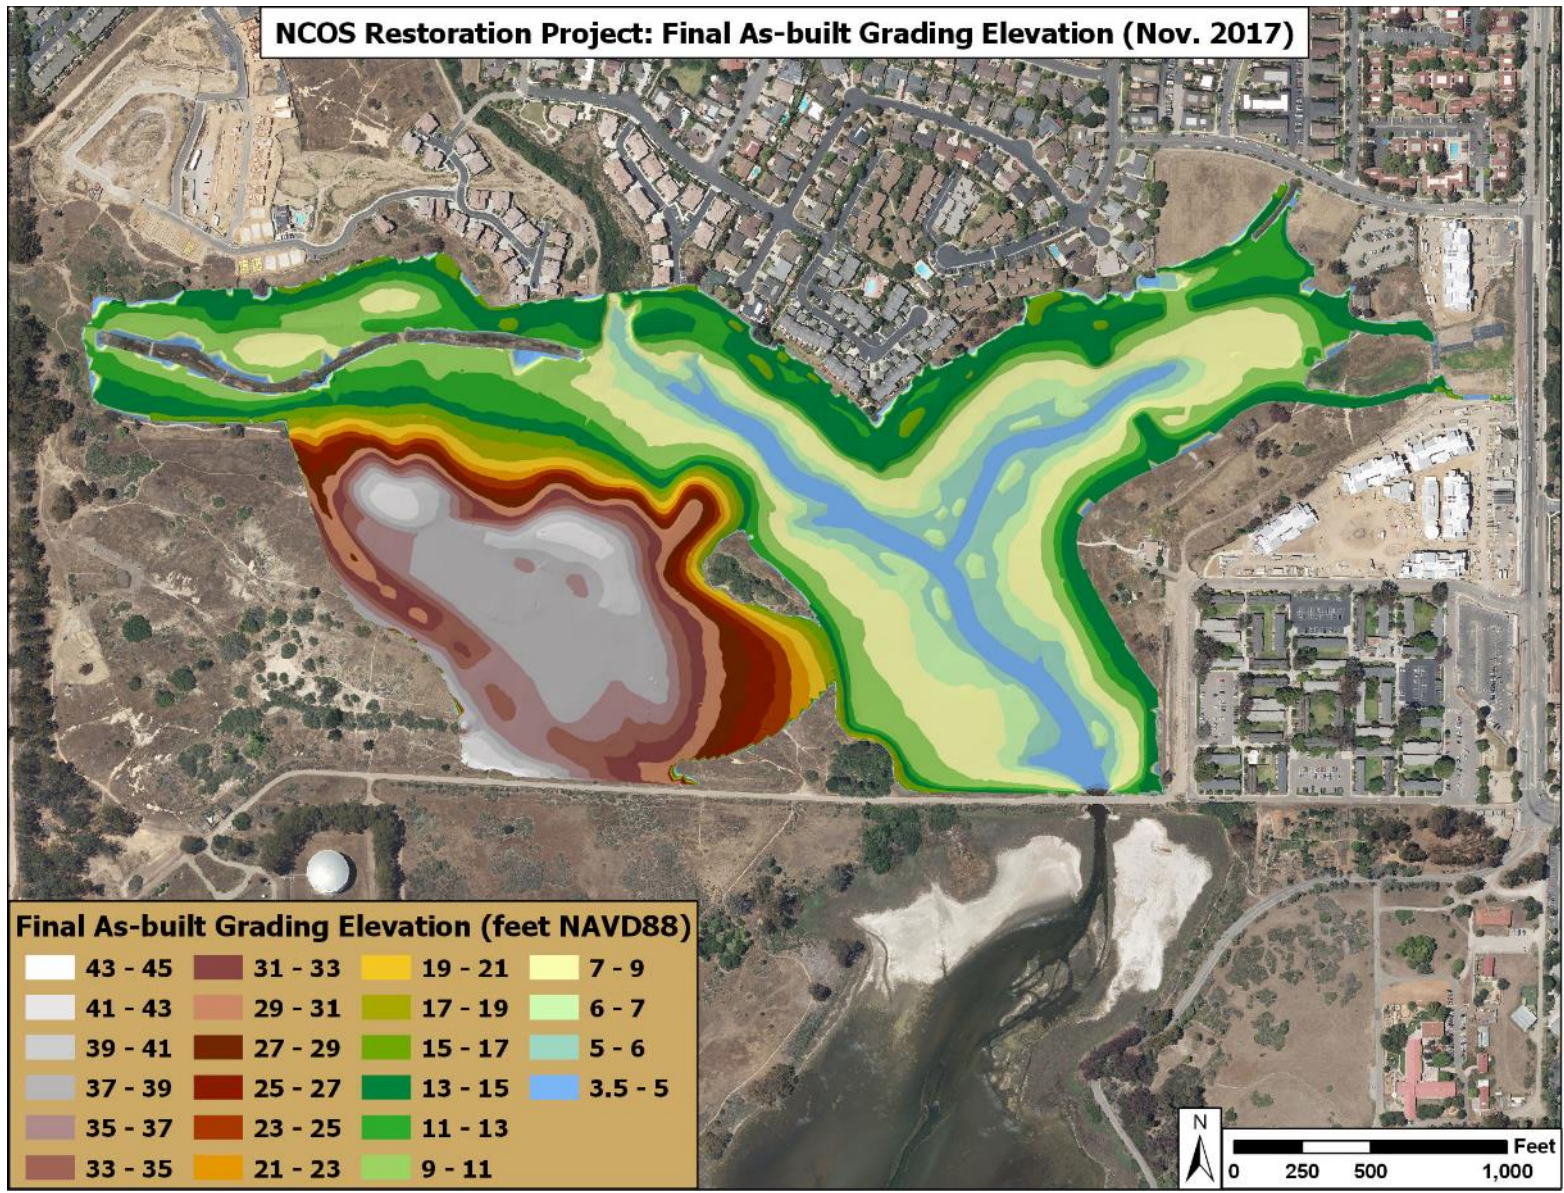
Figure 2. Map showing a representation of the final, as-built grading elevation of the NCOS Restoration Project, derived from an aerial survey digital elevation model completed in November 2017.

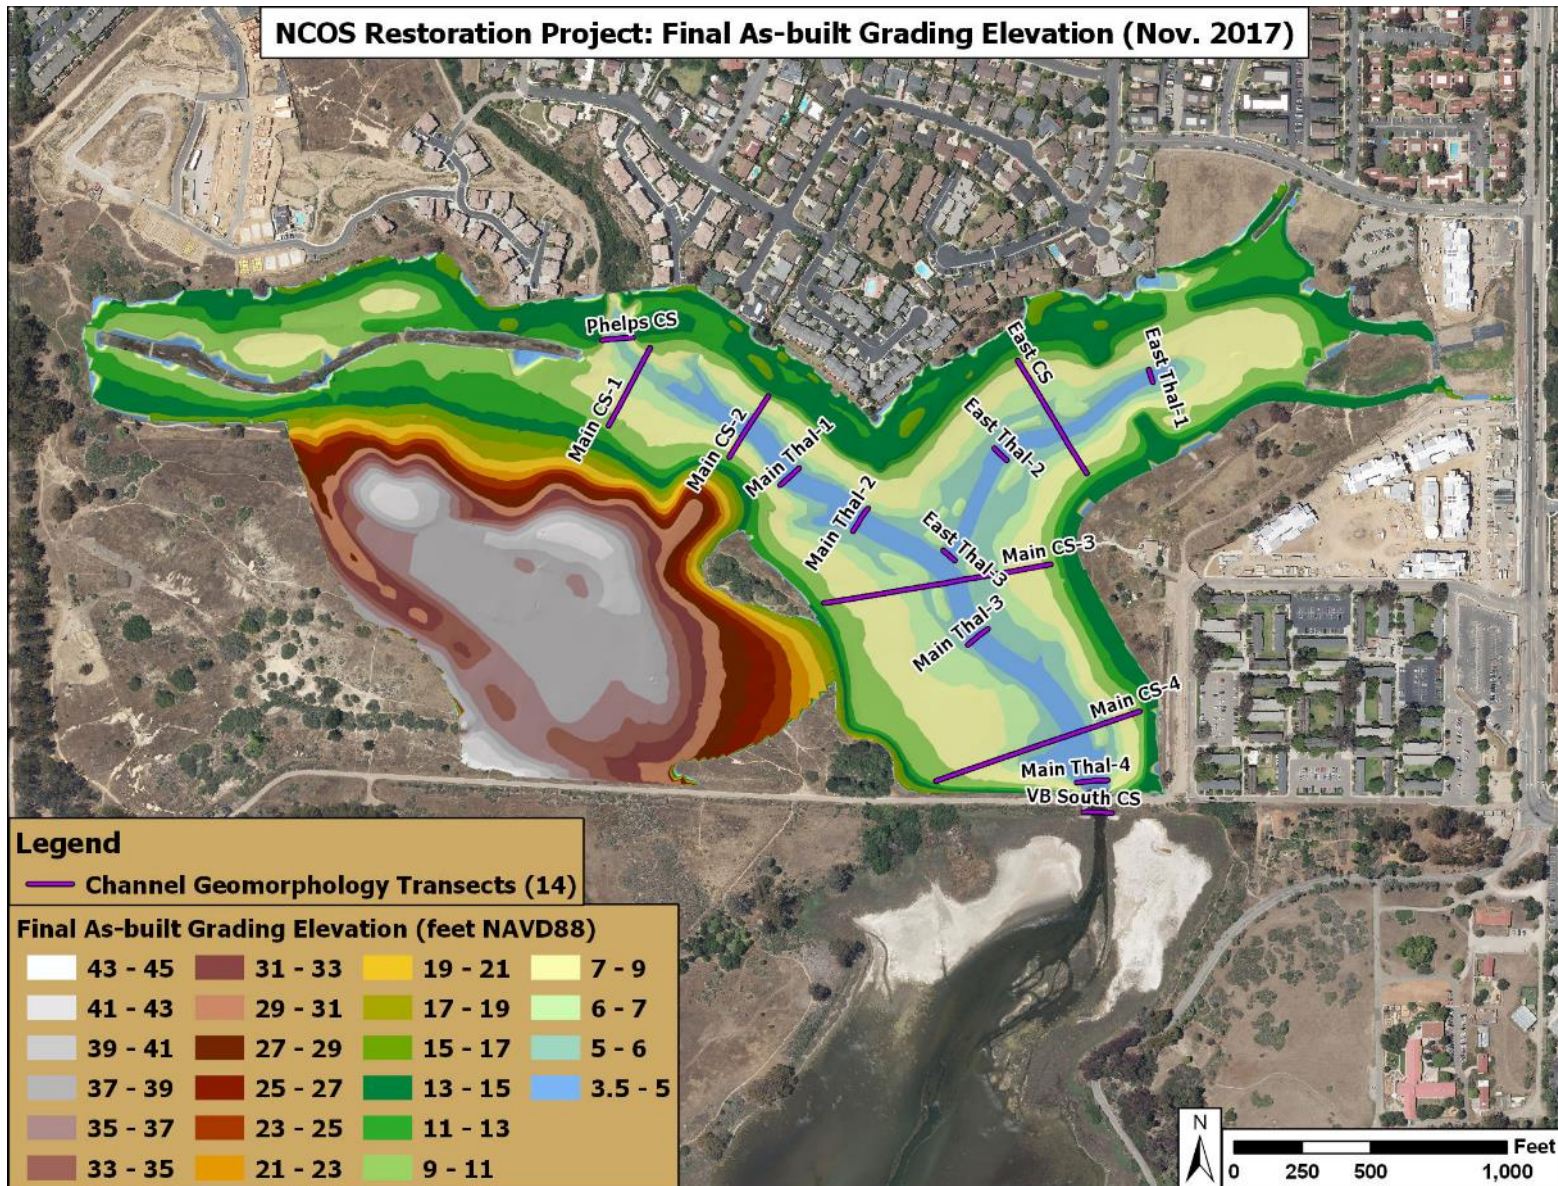
Figure 4. Map showing the Main and East channel geomorphology cross-section and thalweg transects, overlaid on the as-built grading elevation of the NCOS Restoration Project.

Baseline, as-built channel geomorphology cross-section and thalweg transects were established and measured with a high accuracy (within 5 cm) RTK GPS unit in November, 2017, one month after the completion of grading. These include seven cross-section transects between the 10-foot elevation contour lines on opposite sides of the Main and East channels, across Phelps creek (downstream of the bridge) and the downstream side of Venoco Bridge, and seven additional transects across the width of the sub-tidal channel (Figure 4). Profile charts of four of the transects are provided in Figures 5 and 6. The seven sub-tidal transects and the longer Main and East channel cross-sections are used together for an overall baseline thalweg elevation measurement (Table 1). The sub-tidal elevations of these transects demonstrate that the channel bathymetry was constructed as per plan specifications. The baseline cross-section and thalweg transects will be re-surveyed in 2019 and 2021.

**Table 1. Lowest elevations of the East and Main channel cross-section and subtidal transects, which together provide a baseline thalweg elevation of the as-built grading of the NCOS restoration project. Refer to Figure 4 for a map showing the location of each transect.**

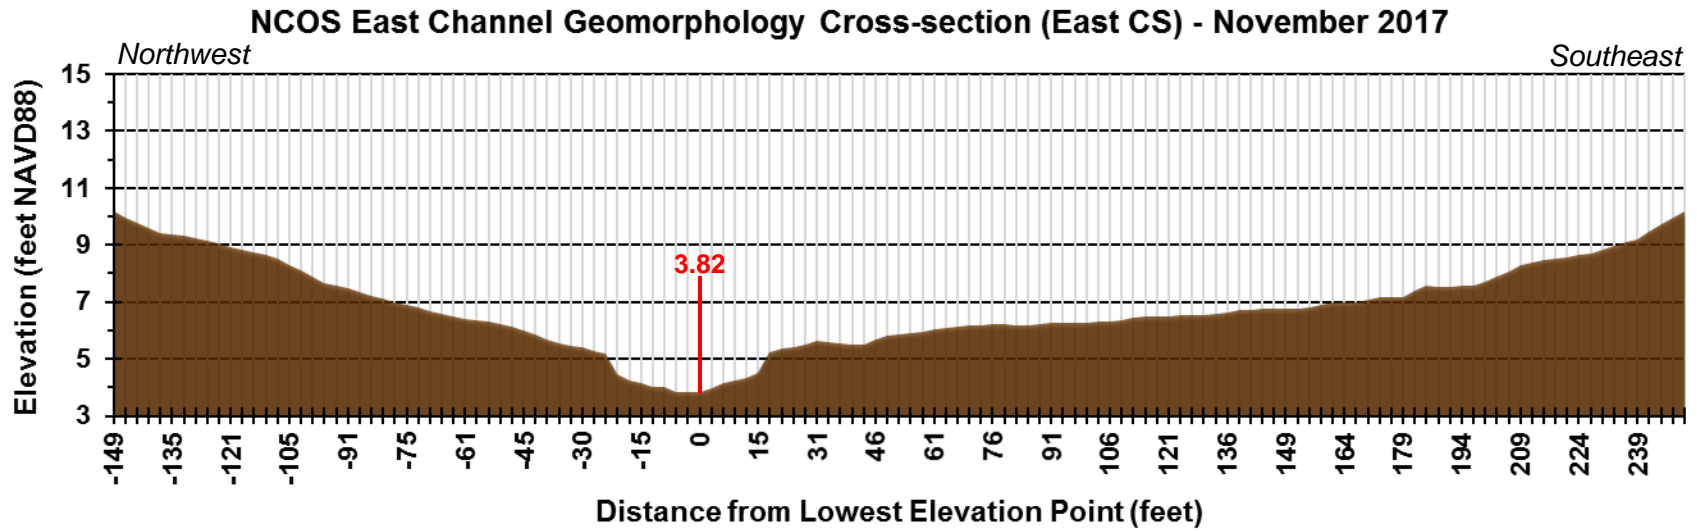
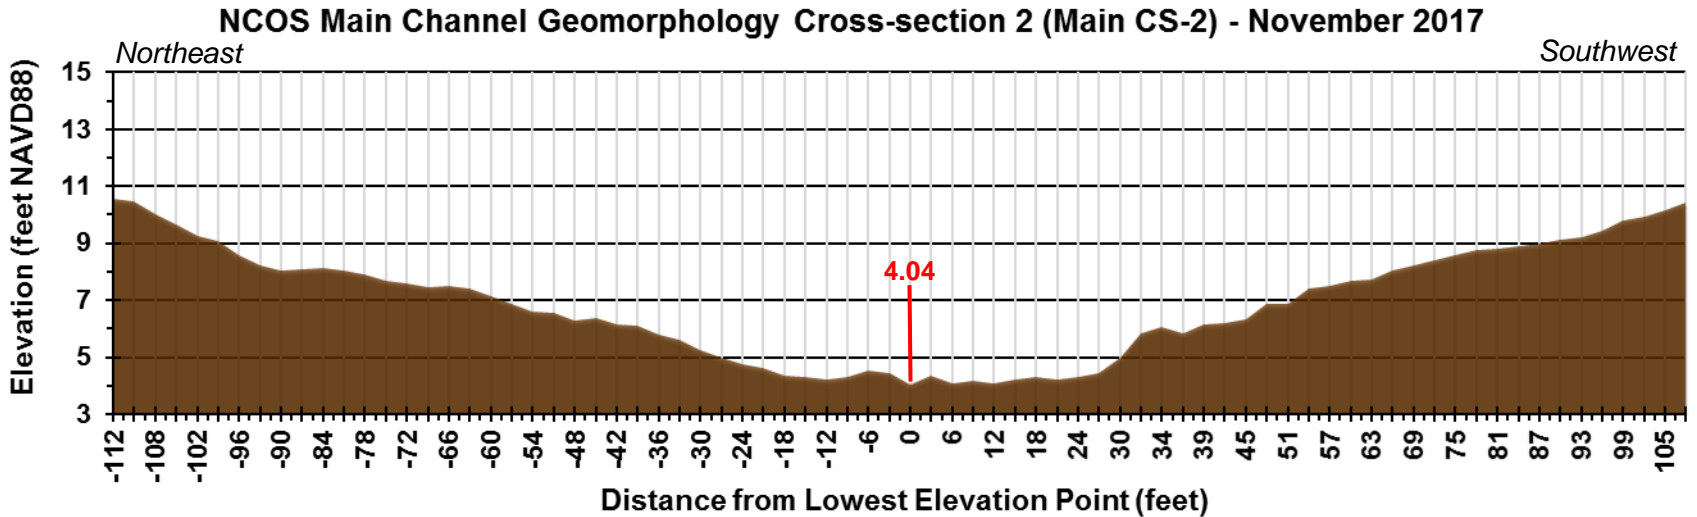
Figure 5. Profiles of as-built elevation cross-section transects in the East Channel (East CS) and the upper portion of the Main Channel (Main CS) of NCOS. The lowest elevation recorded is indicated in red. See Figure 4 for a map of the transects.

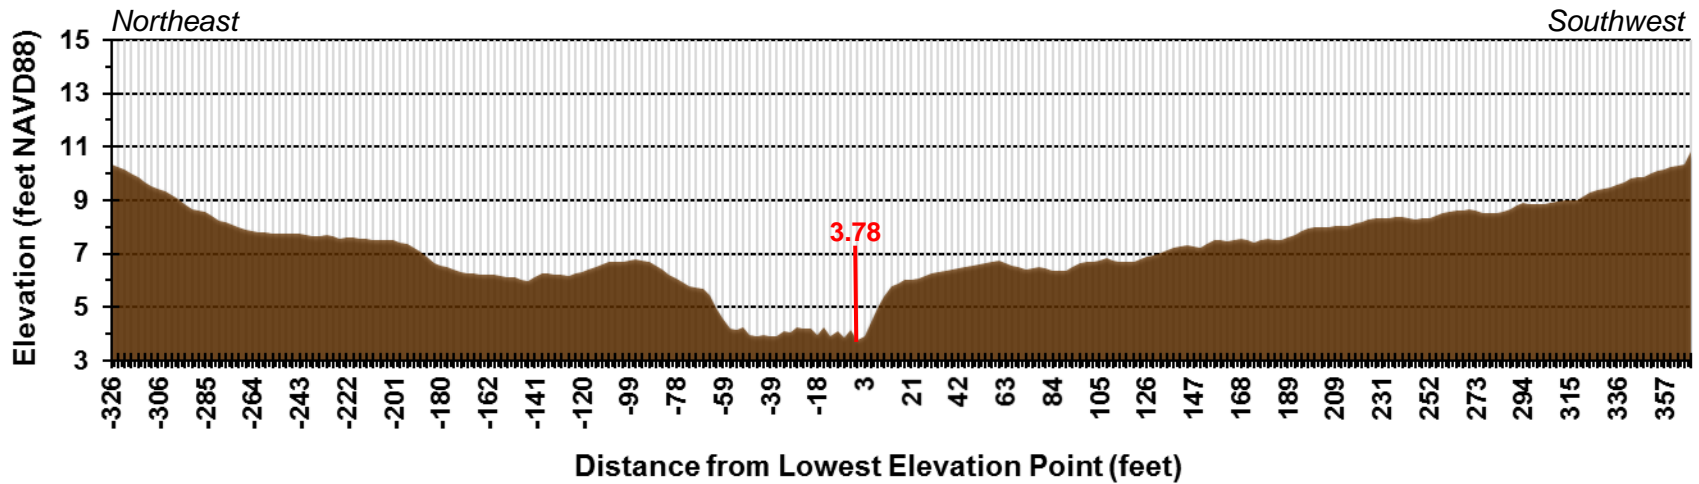
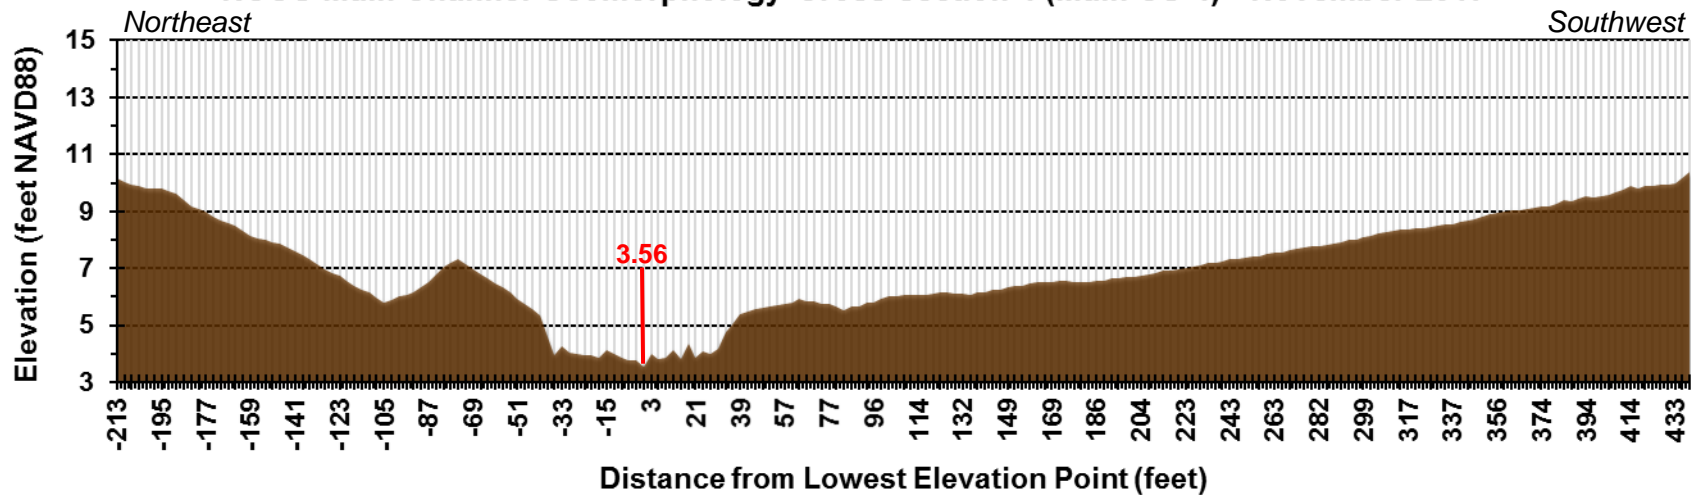
**NCOS Main Channel Geomorphology Cross-section 3 (Main CS-3) - November 2017**

**NCOS Main Channel Geomorphology Cross-section 4 (Main CS-4) - November 2017**

Figure 6. Profiles of as-built elevation cross-section transects in the mid and lower portions of the Main Channel (Main CS) of NCOS. The lowest elevation recorded is indicated in red. See Figure 4 for a map of the transects.

<b>Transect Label (upstream to downstream)</b>	<b>Lowest Elevation (feet NAVD88)</b>
East Thal-1	3.87
East CS	3.82
East Thal-2	3.67
East Thal-3	3.39
Main CS-1	5.45
Main CS-2	4.04
Main Thal-1	3.71
Main Thal-2	3.78
Main CS-3	3.78
Main Thal-3	3.62
Main CS-4	3.56
Main Thal-4	3.24

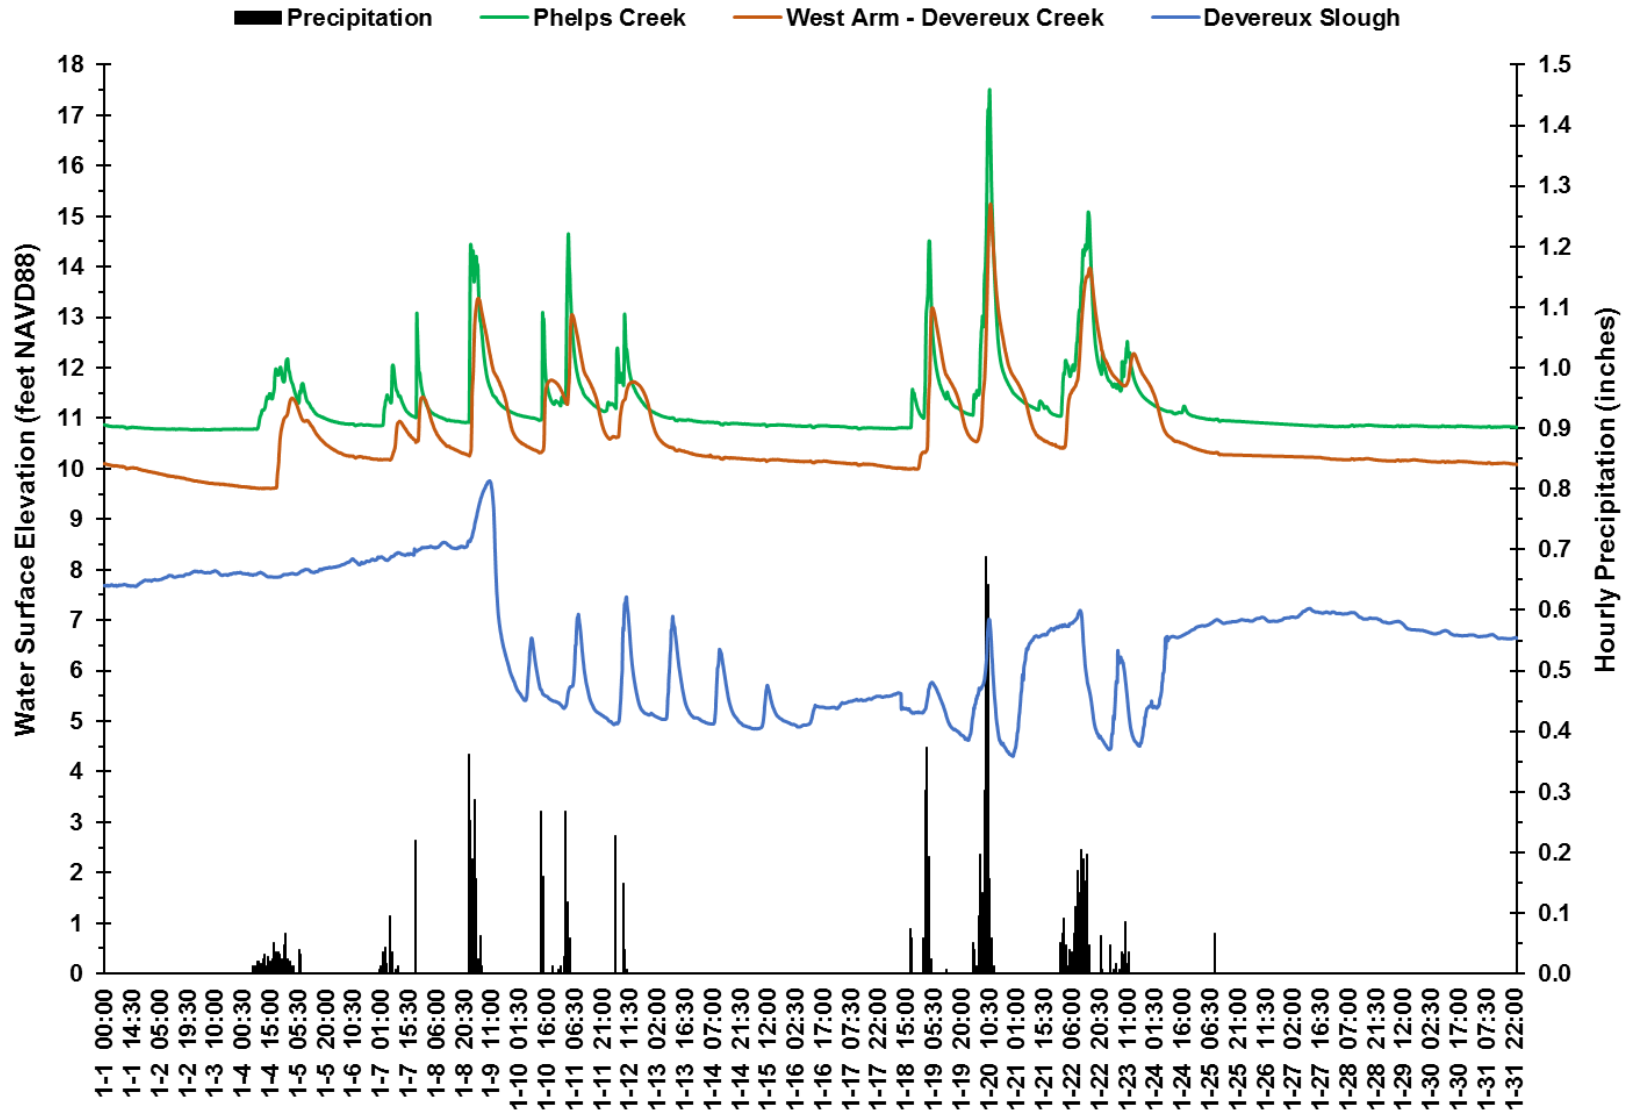
### Precipitation and Water Elevations in NCOS Tributaries and Devereux Slough - January 2017

Figure 7. Pre-grading NCOS water surface elevations and precipitation, January 2017.

Prior to the NCOS restoration project, half of the wetland's potential water-holding capacity was supplanted by soil deposited to create the golf course. This caused water levels to rise rapidly to flood levels at the interface between the incoming creeks and the former wetland. Before the restoration of NCOS began, water levels recorded in Phelps and Devereux Creeks would rise by at least 3 feet immediately following rainfall amounts above 0.3 inches per hour, as was recorded in January 2017 (Figure 7). In March 2018, five months after the completion of the grading of the restoration project, the amount of water level rise has decreased by a foot or more in both creeks following similar rain events (Figure 8). See Figure 9 for a map showing the location of the water level loggers.

In the winter of 2016-17, it took 6 inches of rain to cause Devereux Slough to breach the sand bar (on 1/9/17) and connect the system to the ocean. Following the completion of the grading in October 2017, the slough did not breach until rainfall totals reached 7.8 inches on 3/22/18, reflecting an increased water holding capacity of the system. This increased capacity is also reflected in the hypsometric curve in Figure 10. The sand bar at the mouth of the slough usually holds the water in the system up to about 9.5 feet elevation. The blue line in Figure 9 shows the capacity of the system before the project, when the mouth would breach after holding about 200 acre feet of water. The orange line shows the post-project capacity of the system, indicating it will hold closer to 350 acre feet before it breaches. The conclusion is that the hydrology of the as-built, restored system at NCOS closely follows the modeled predictions, and provides increased wetland capacity, habitat diversity and flood protection.

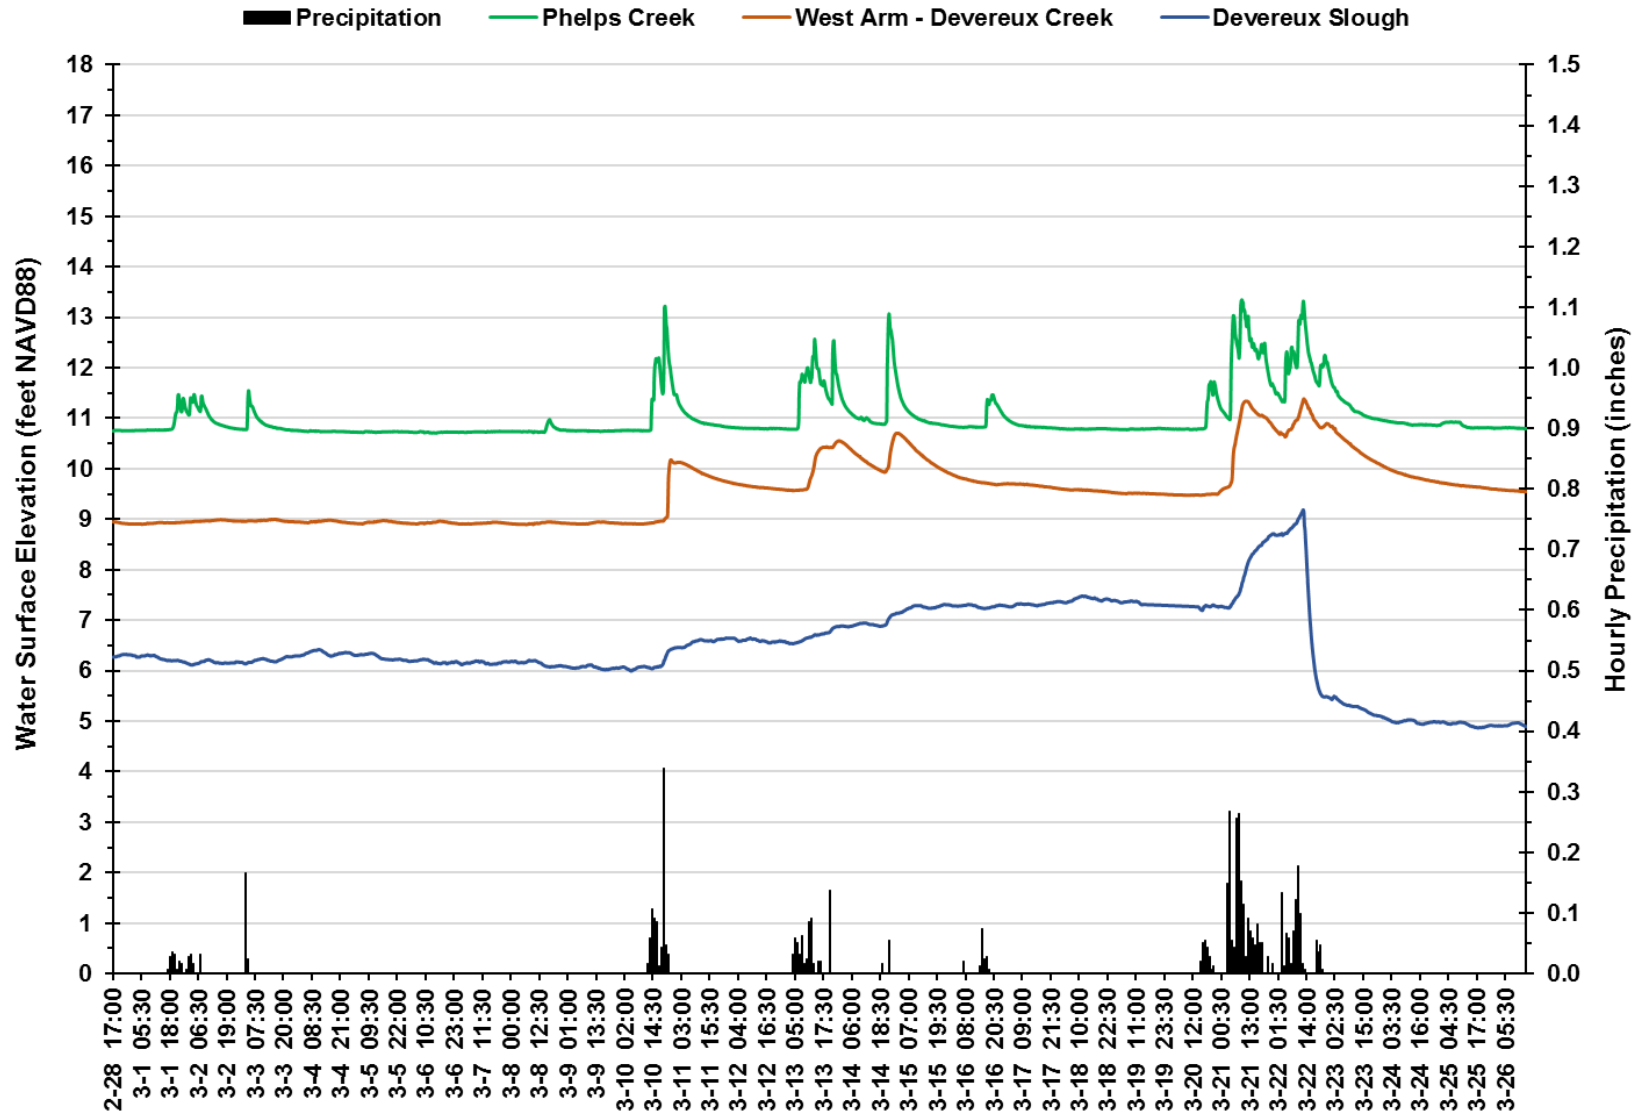
### Precipitation and Water Elevations in NCOS Tributaries and Devereux Slough - March 2018

Figure 8. Post-grading NCOS water surface elevations and precipitation, March 2018.

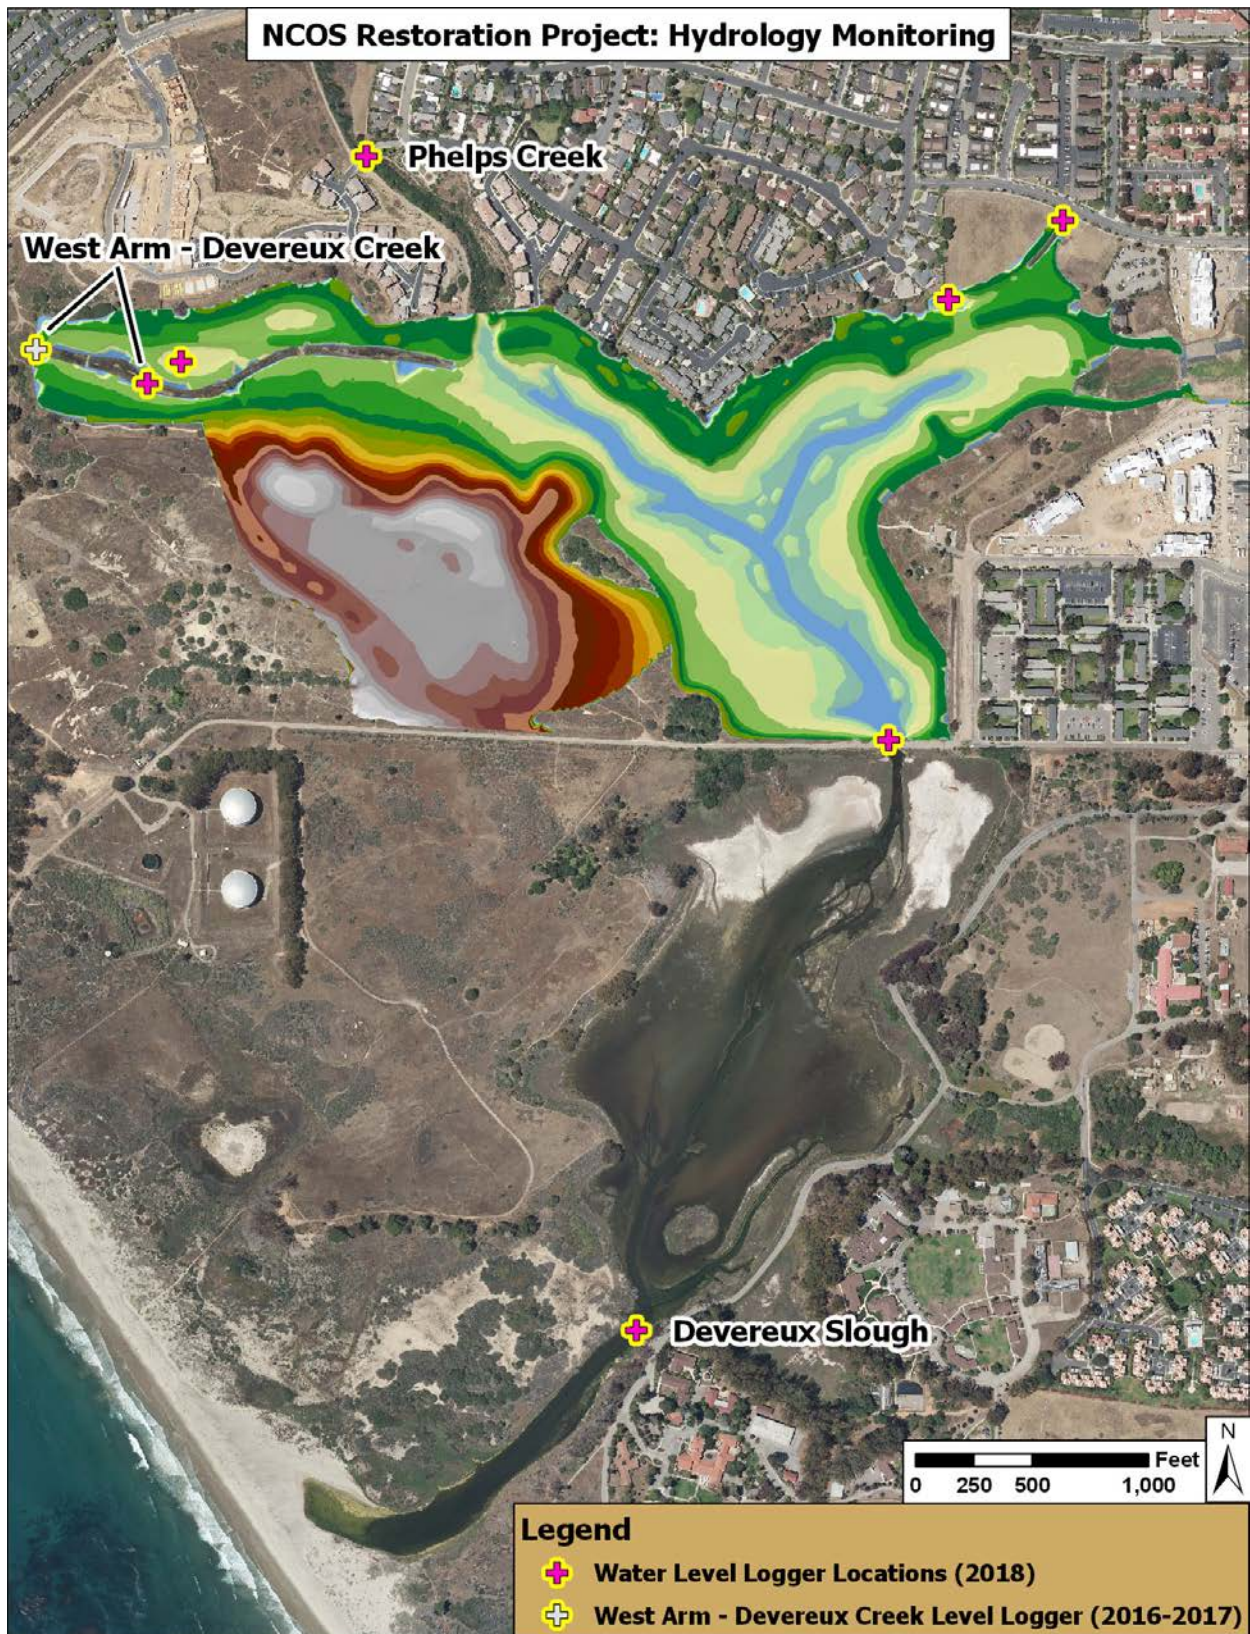
Figure 9. Map of the location of water level loggers for monitoring hydrology of the NCOS restoration site and lower Devereux Slough before (2016-2017) and after completion of the grading phase of the project.

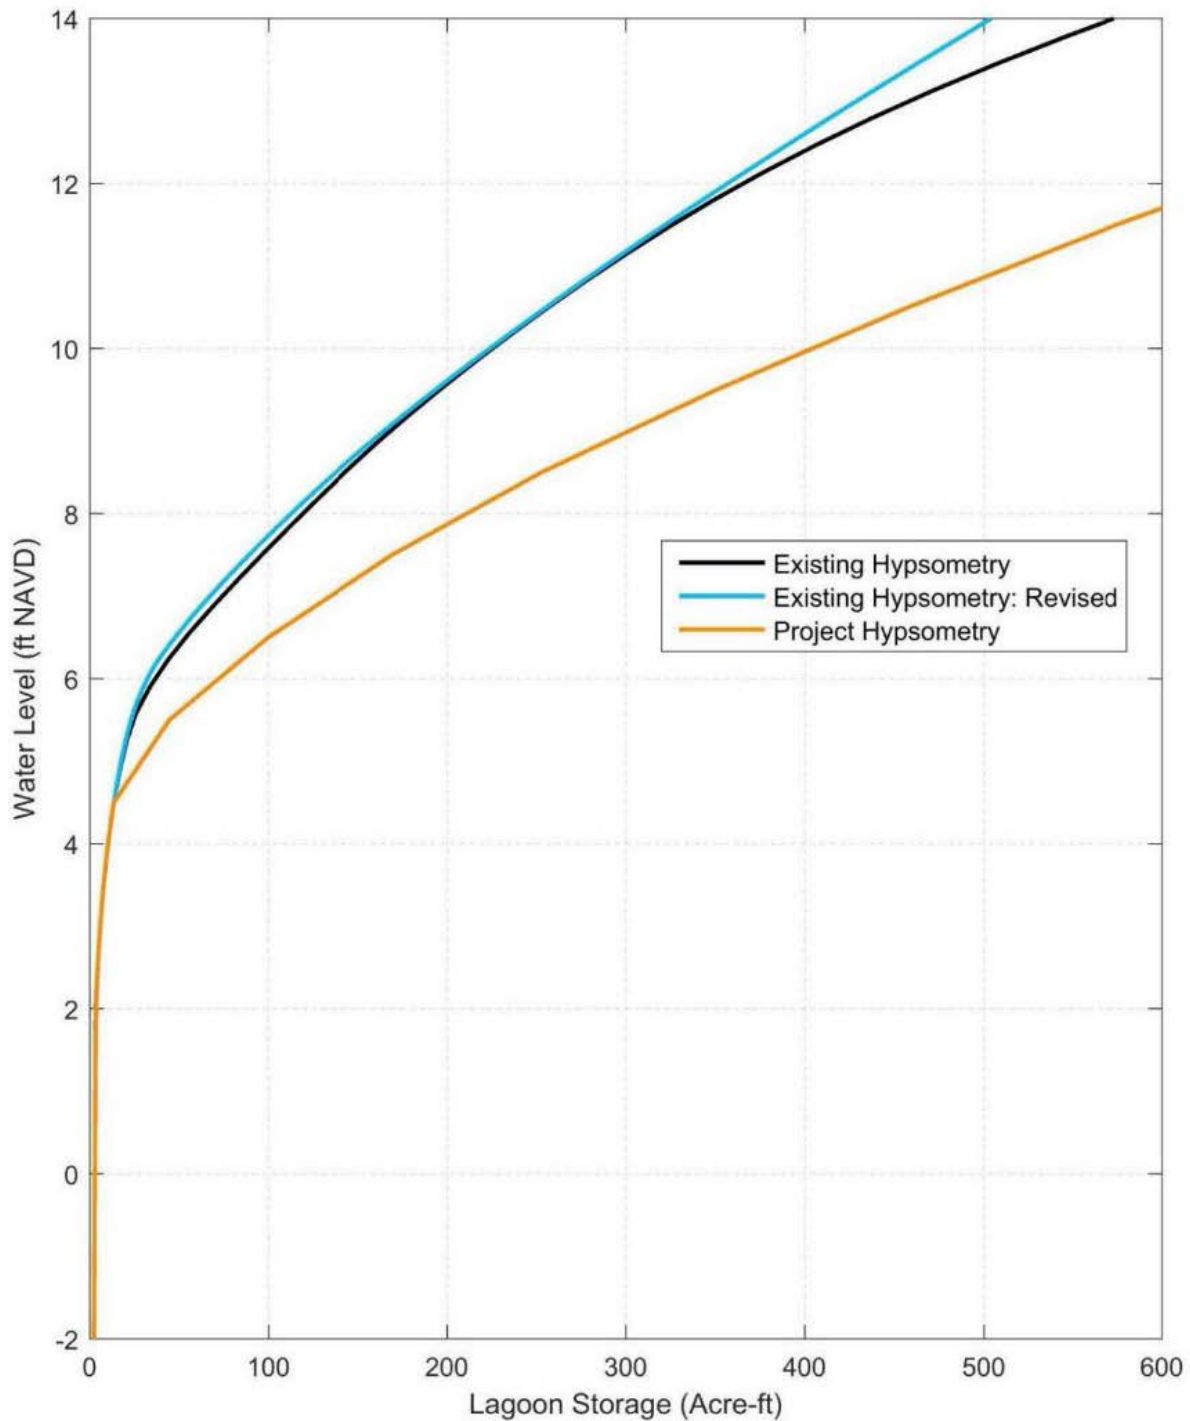
**Figure 10. Comparison of pre- and post-grading water stage-storage curves for Devereux Slough (Lagoon). Notice the lower post-project water levels at equivalent water storage levels (orange line). Pre-grading hypsometry is from Rich (2013). Revised pre-grading hypsometry is based on an ESA and Stantec survey. Post-grading hypsometry is based on the ESA grading plan for NCOS.**

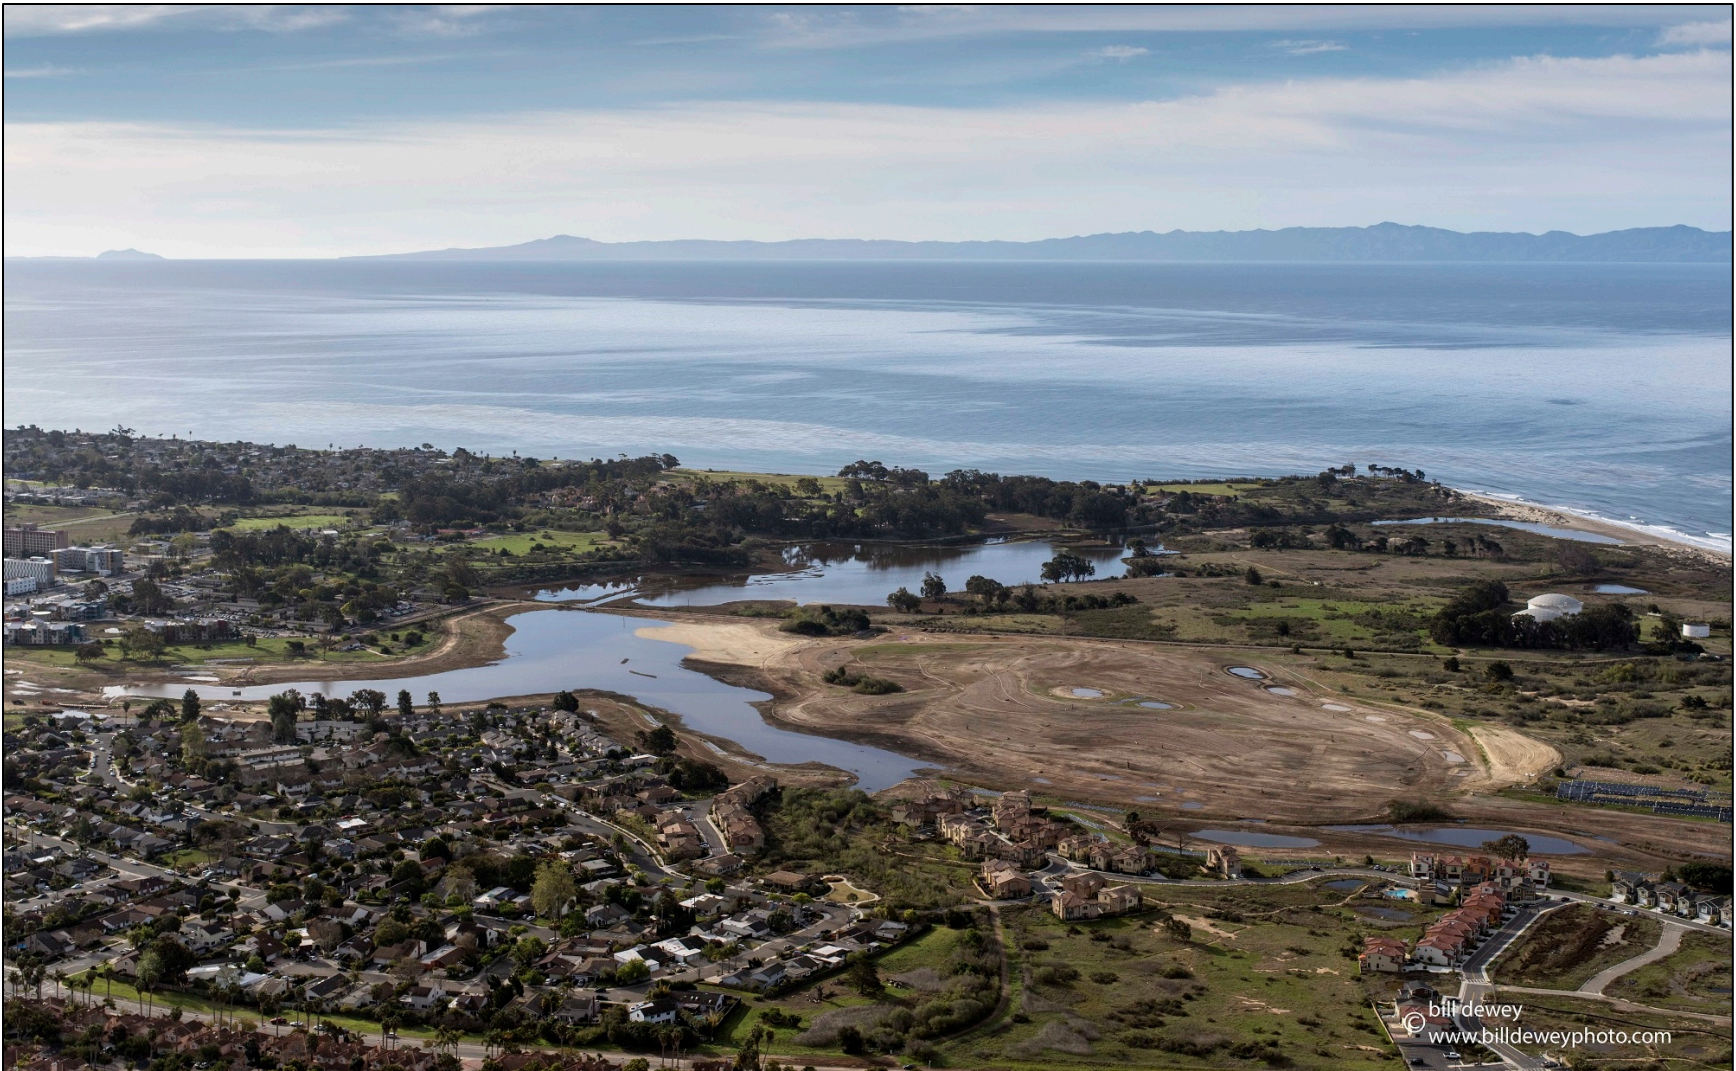
**Aerial image of the North Campus Open Space project site after the completion of the grading phase, taken by Bill Dewey on March 18, 2018.**

Oblique aerial photos of the NCOS project site have been periodically captured by Bill Dewey. One pre- and one post-grading aerial photo are provided on the following two pages. Quarterly landscape photo monitoring of the NCOS restoration project began in December 2016, with the first complete set of baseline, pre-grading photos taken on April 10-11, 2017. On the following pages, a subset of key photos from this baseline set are compared with photos taken after the completion of grading (April 2018). The photos are preceded by a map of the photo monitoring point locations, with the key subset photo point locations highlighted for reference (Figure 11).

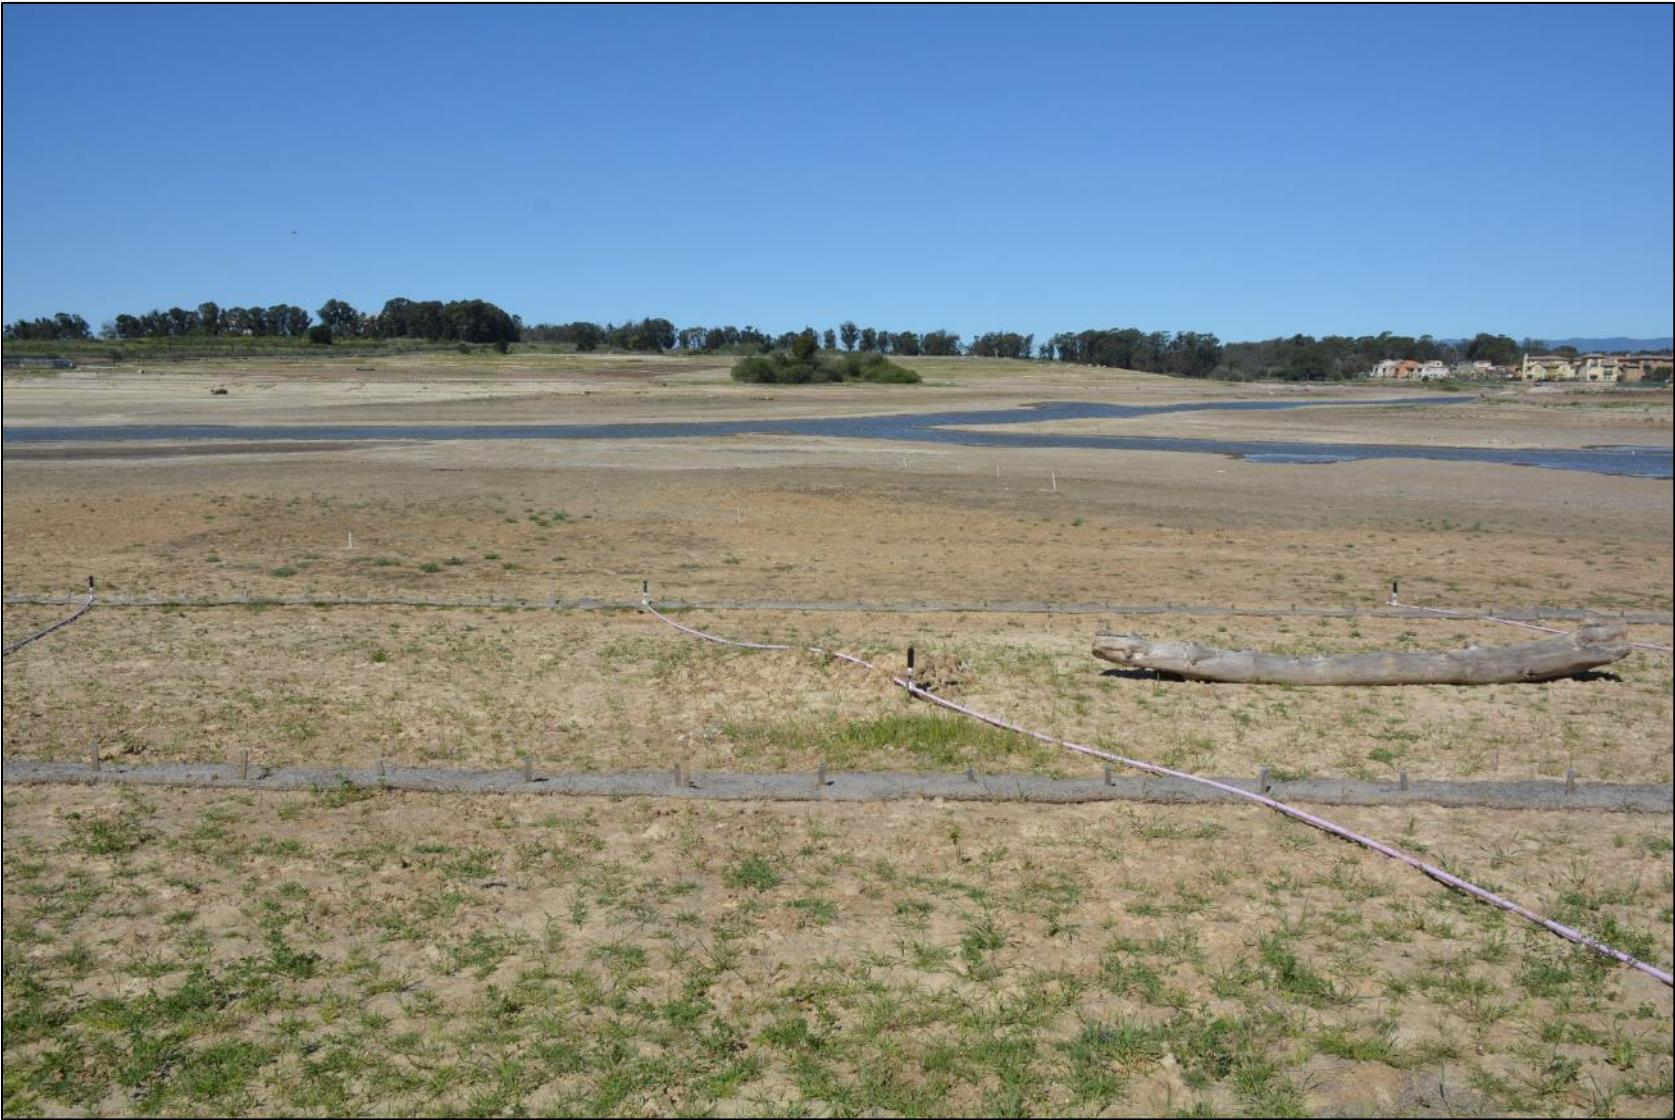
**Photo point 32-W – looking west from central point on the trail along the eastern side of NCOS project site**

**Baseline photo – pre-grading, April 10, 2017.**
