**North Campus Open Space Restoration Project  
As-Built Grading and Hydrology Report**

**July 2018**

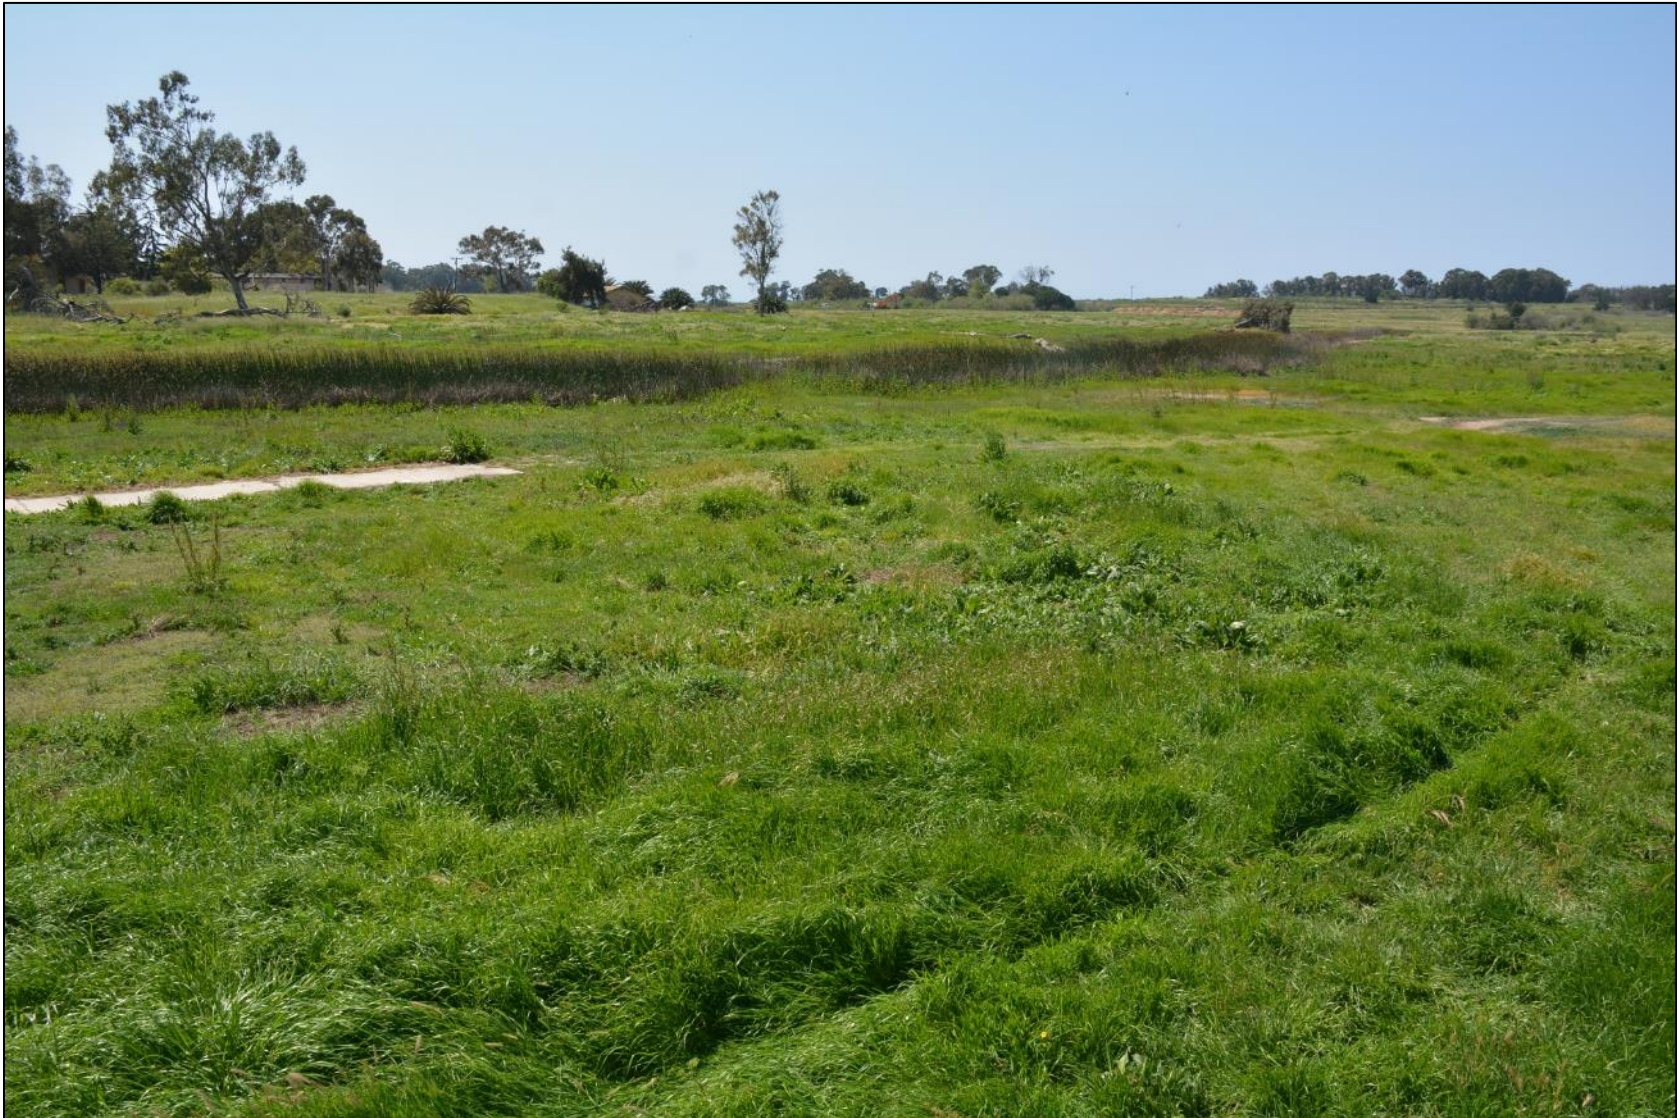
**Photo point 37-S – looking south from primary trail along northeast side of NCOS project site**

**As-built photo - April 17, 2018.**

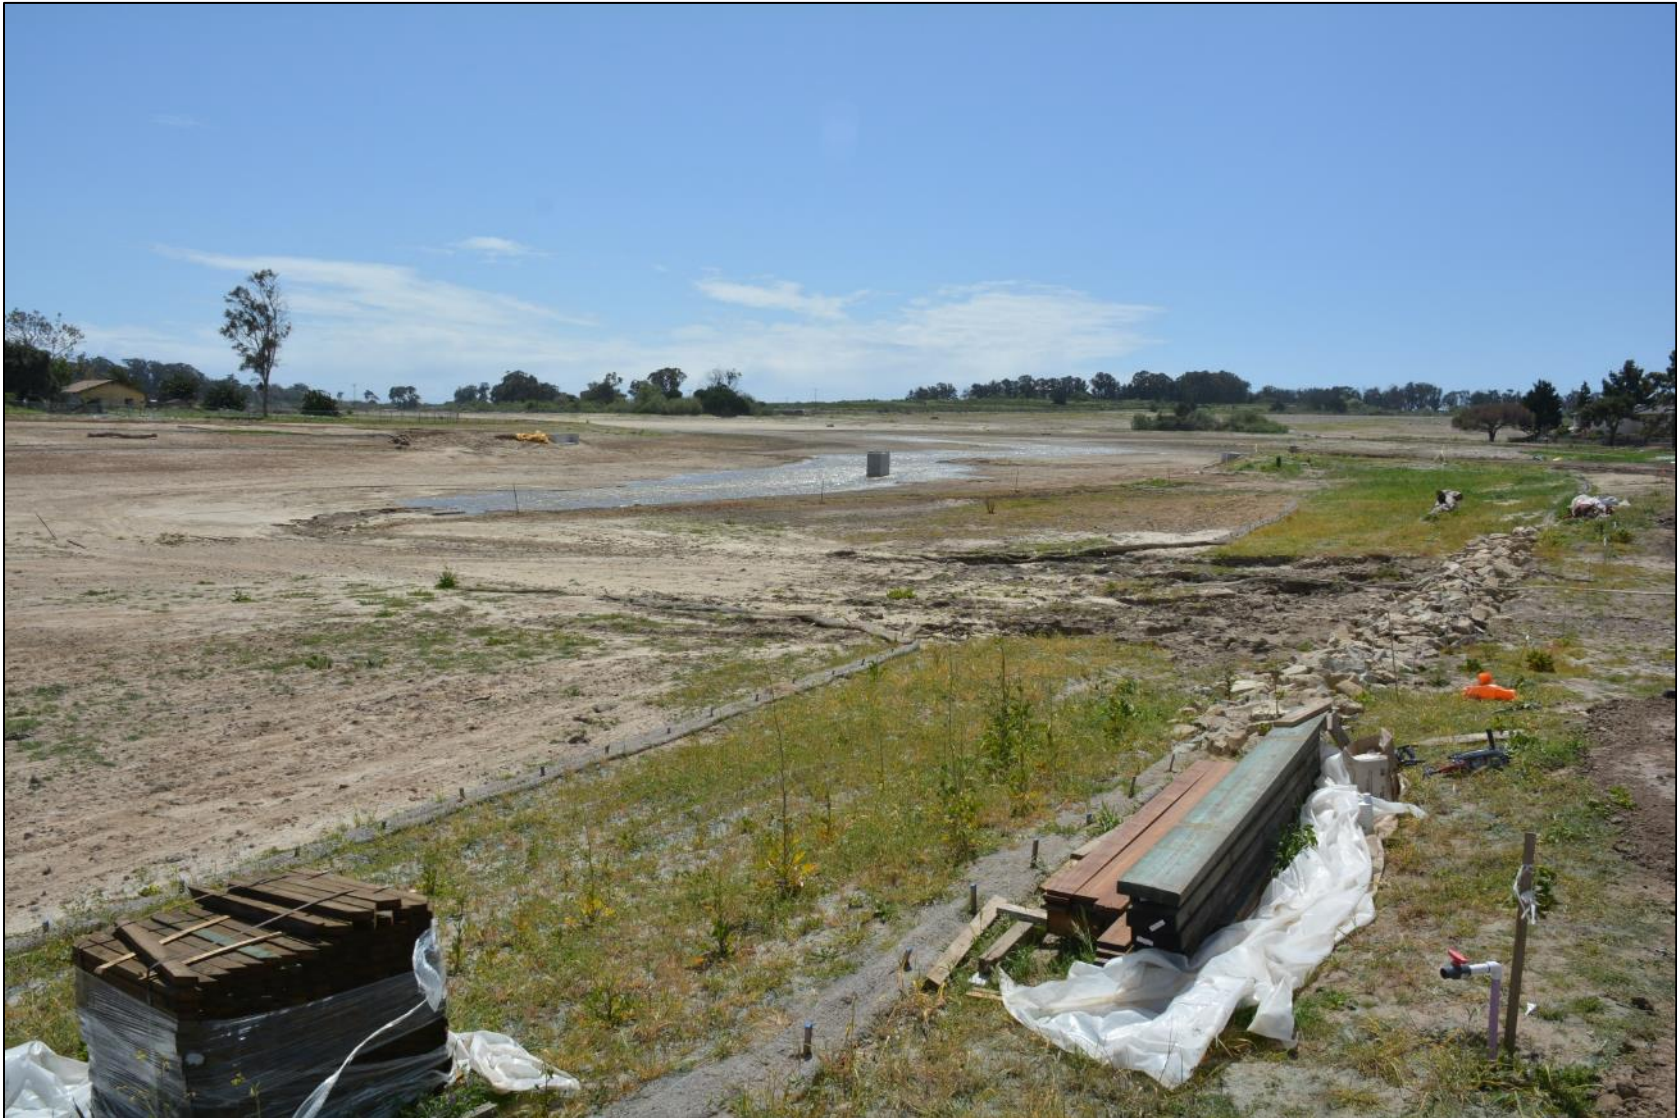
**Photo point 37-S – looking south from primary trail along northeast side of NCOS project site**

**Baseline photo – pre-grading, April 10, 2017.**

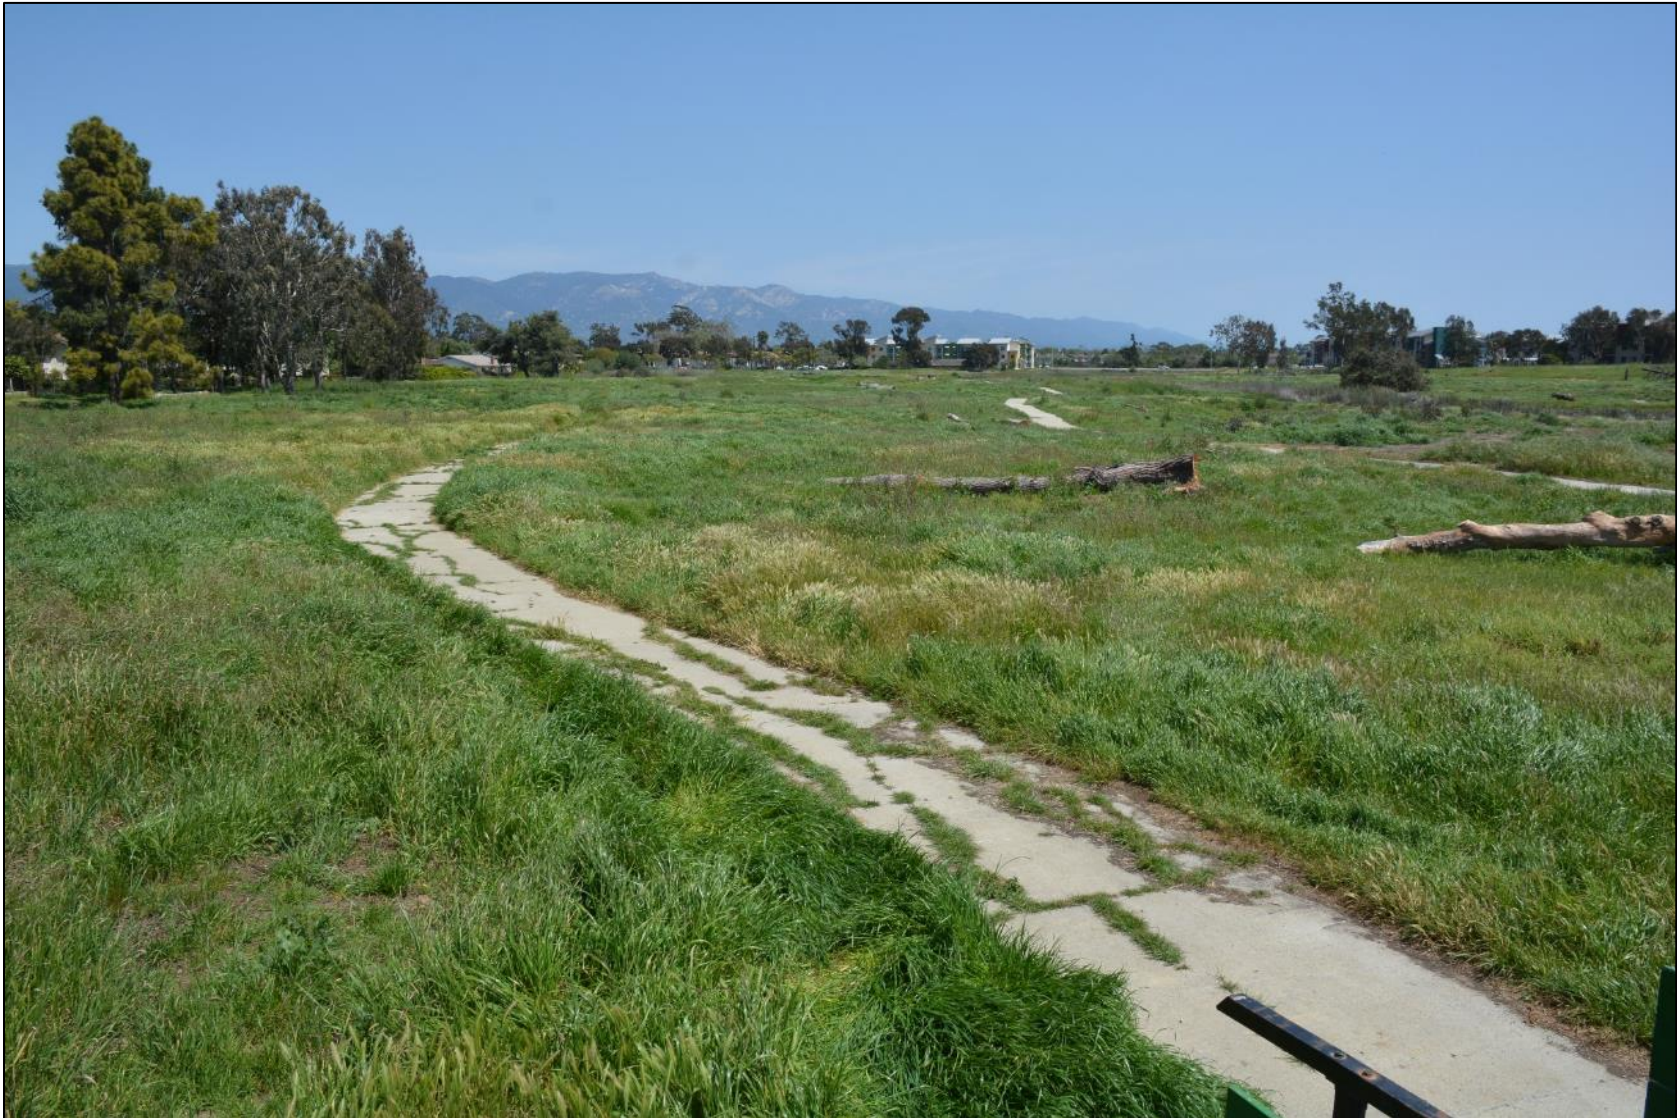
**Photo point 42-NE – looking northeast from central point on trail along north side of NCOS project site**

**As-built photo - April 16, 2018.**

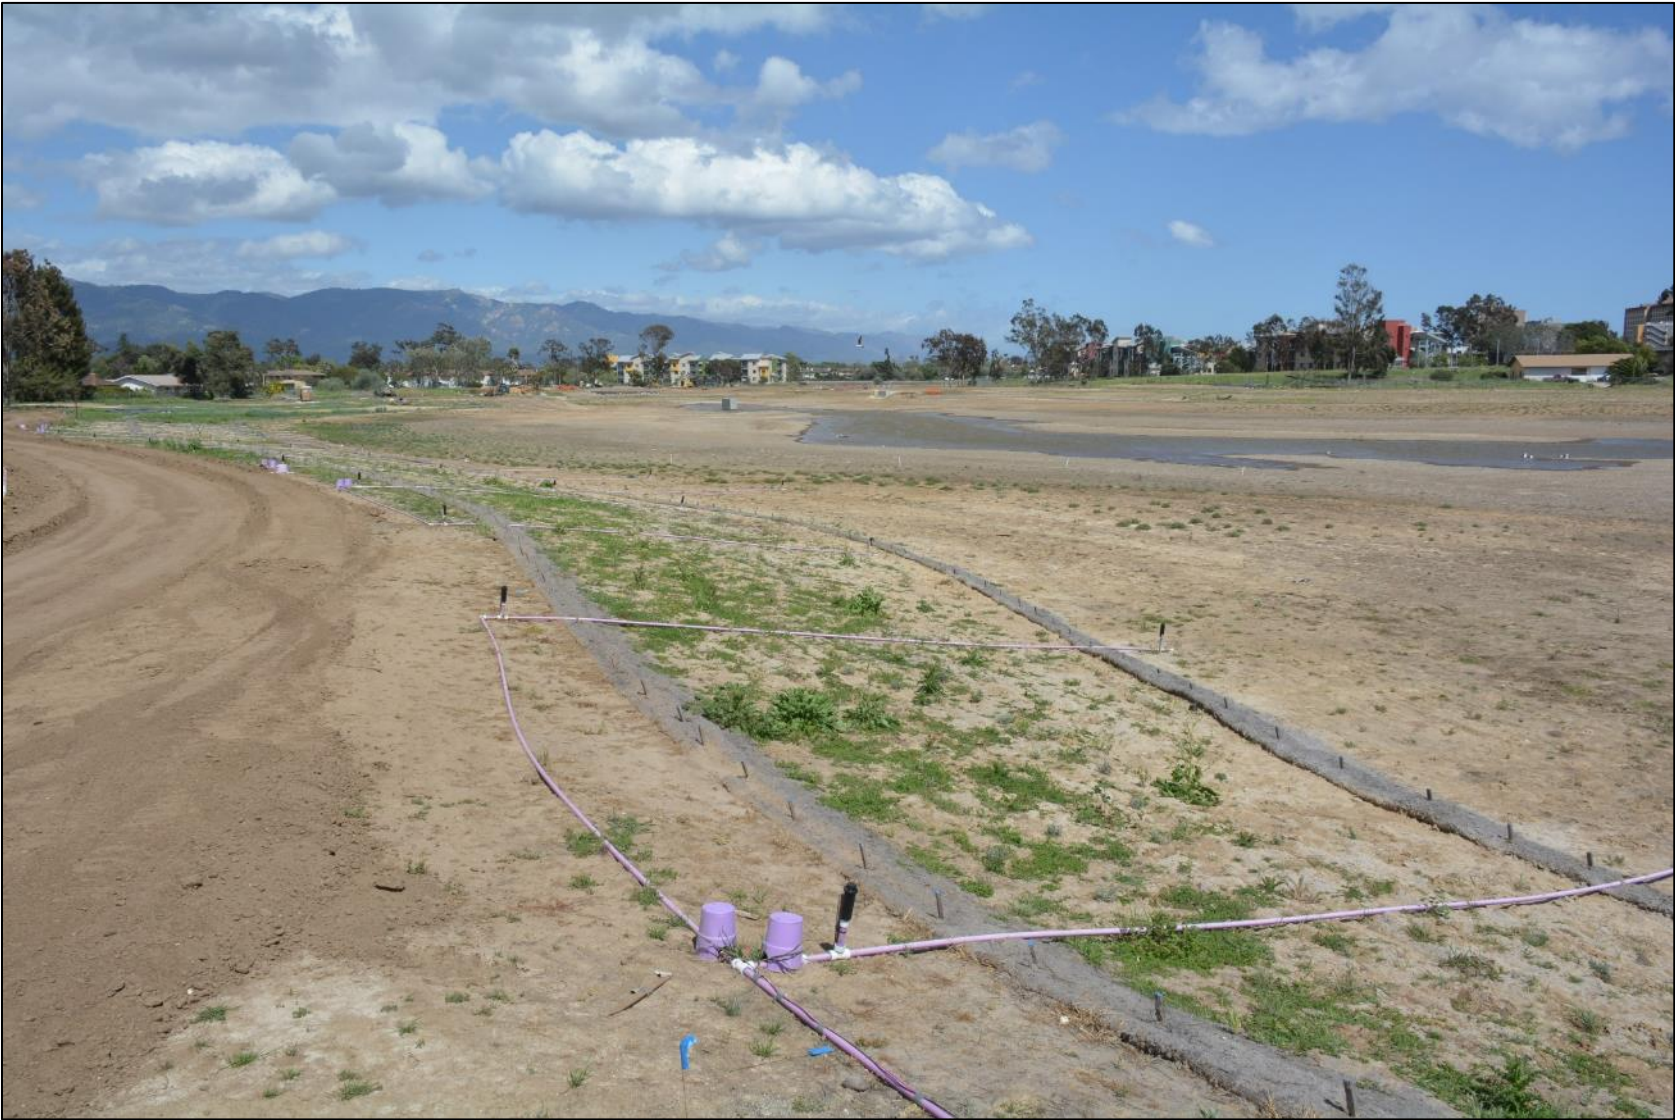
**Photo point 42-NE – looking northeast from central point on trail along north side of NCOS project site**

**Baseline photo – pre-grading, April 10, 2017.**

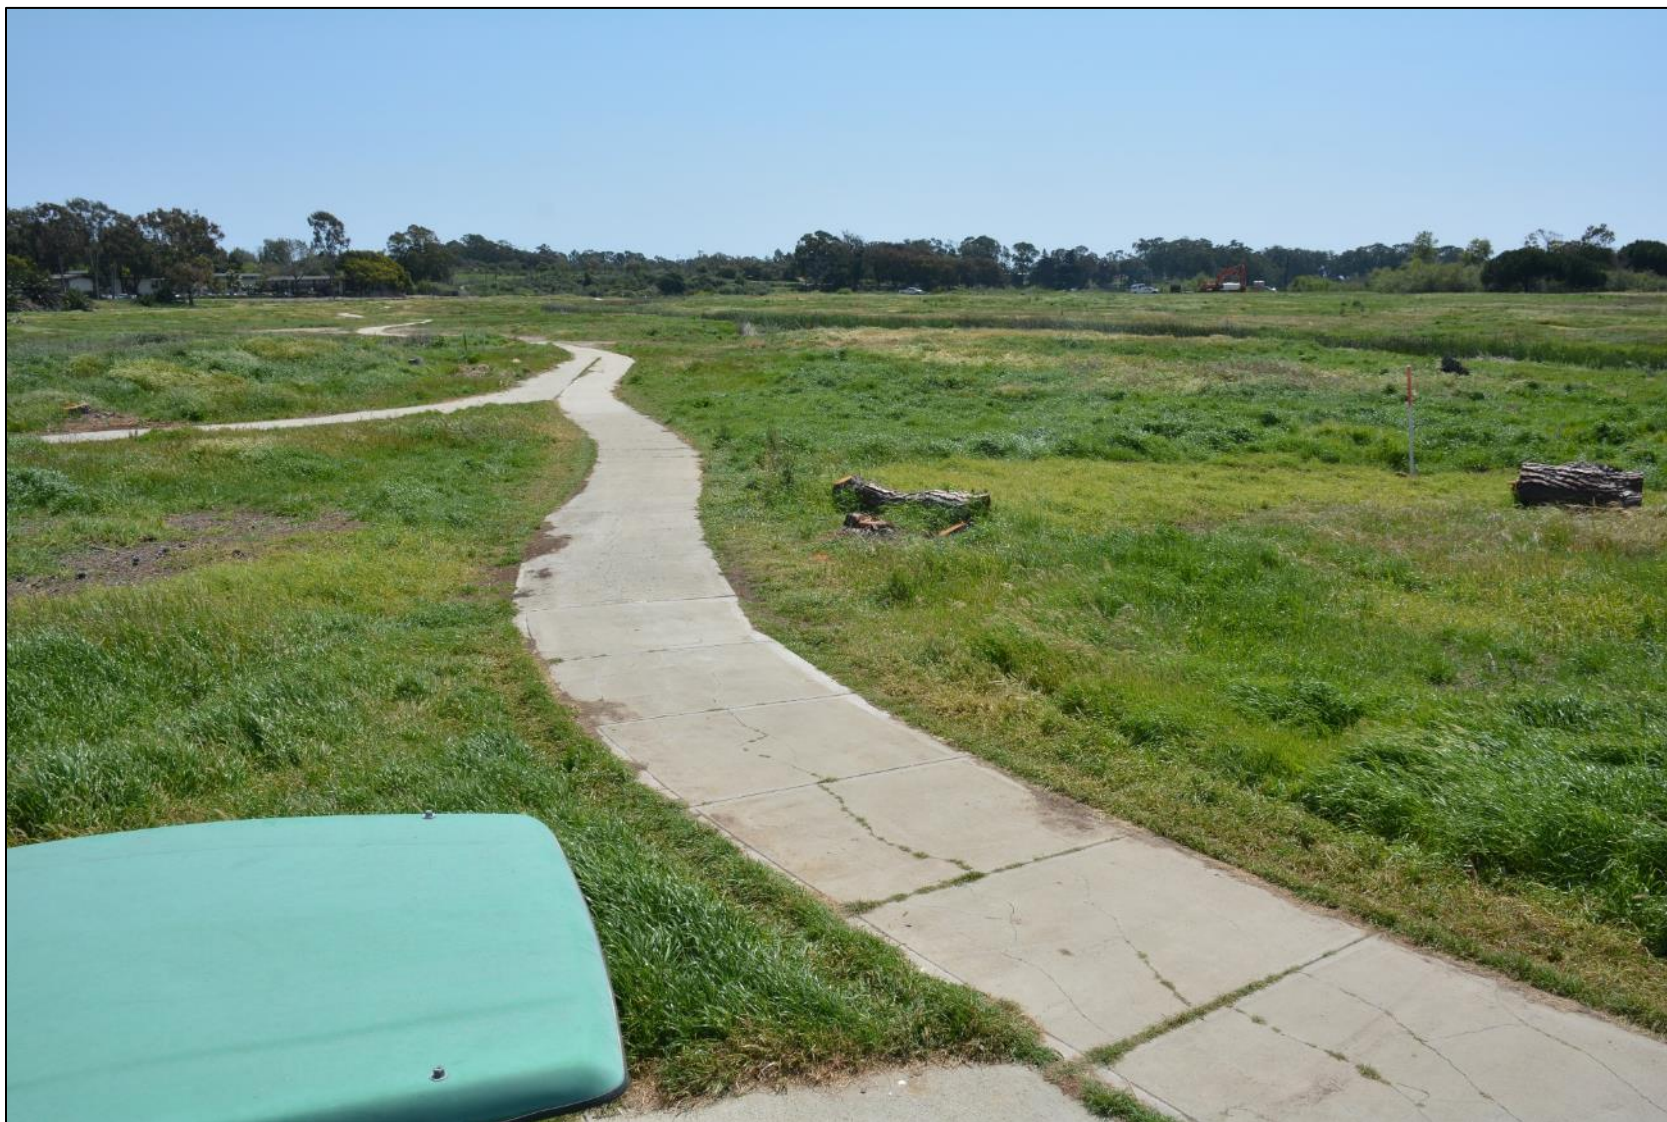
**Photo point 42-SE – looking southeast from central point on trail along north side of NCOS project site**

**As-built photo - April 16, 2018.**

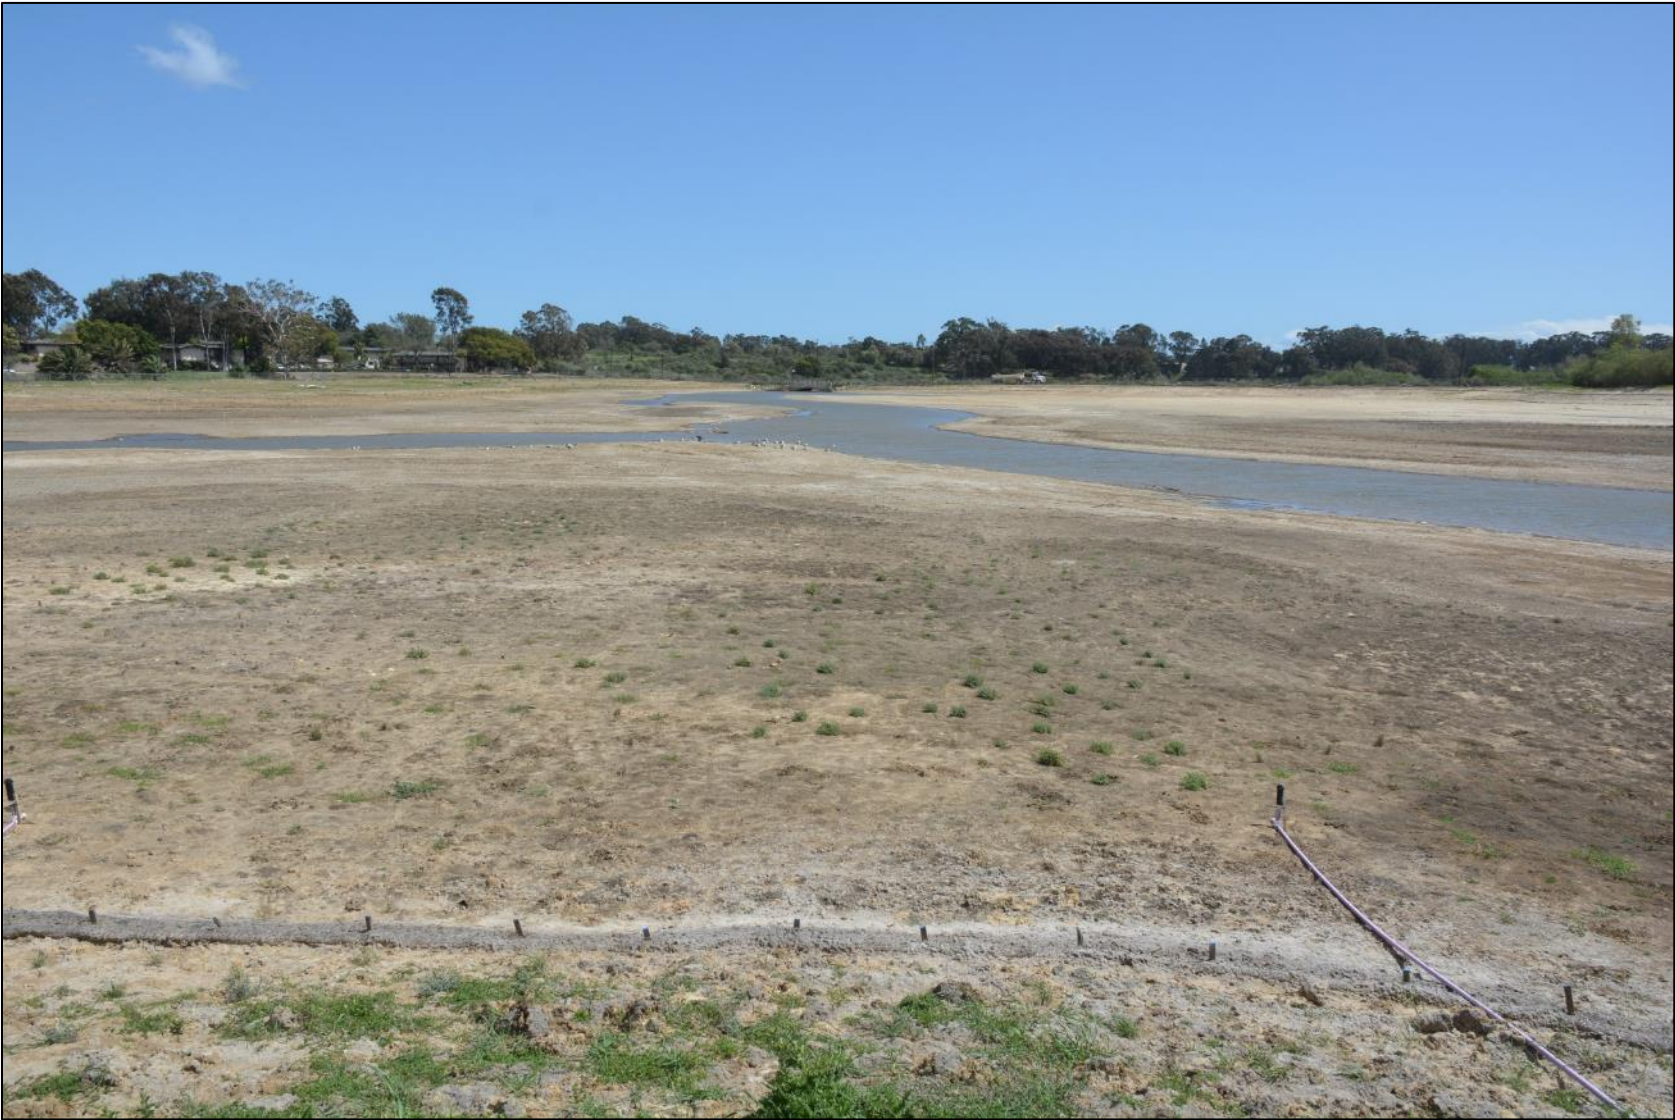
**Photo point 42-SE – looking southeast from central point on trail along north side of NCOS project site**

**Baseline photo – pre-grading, April 10, 2017.**

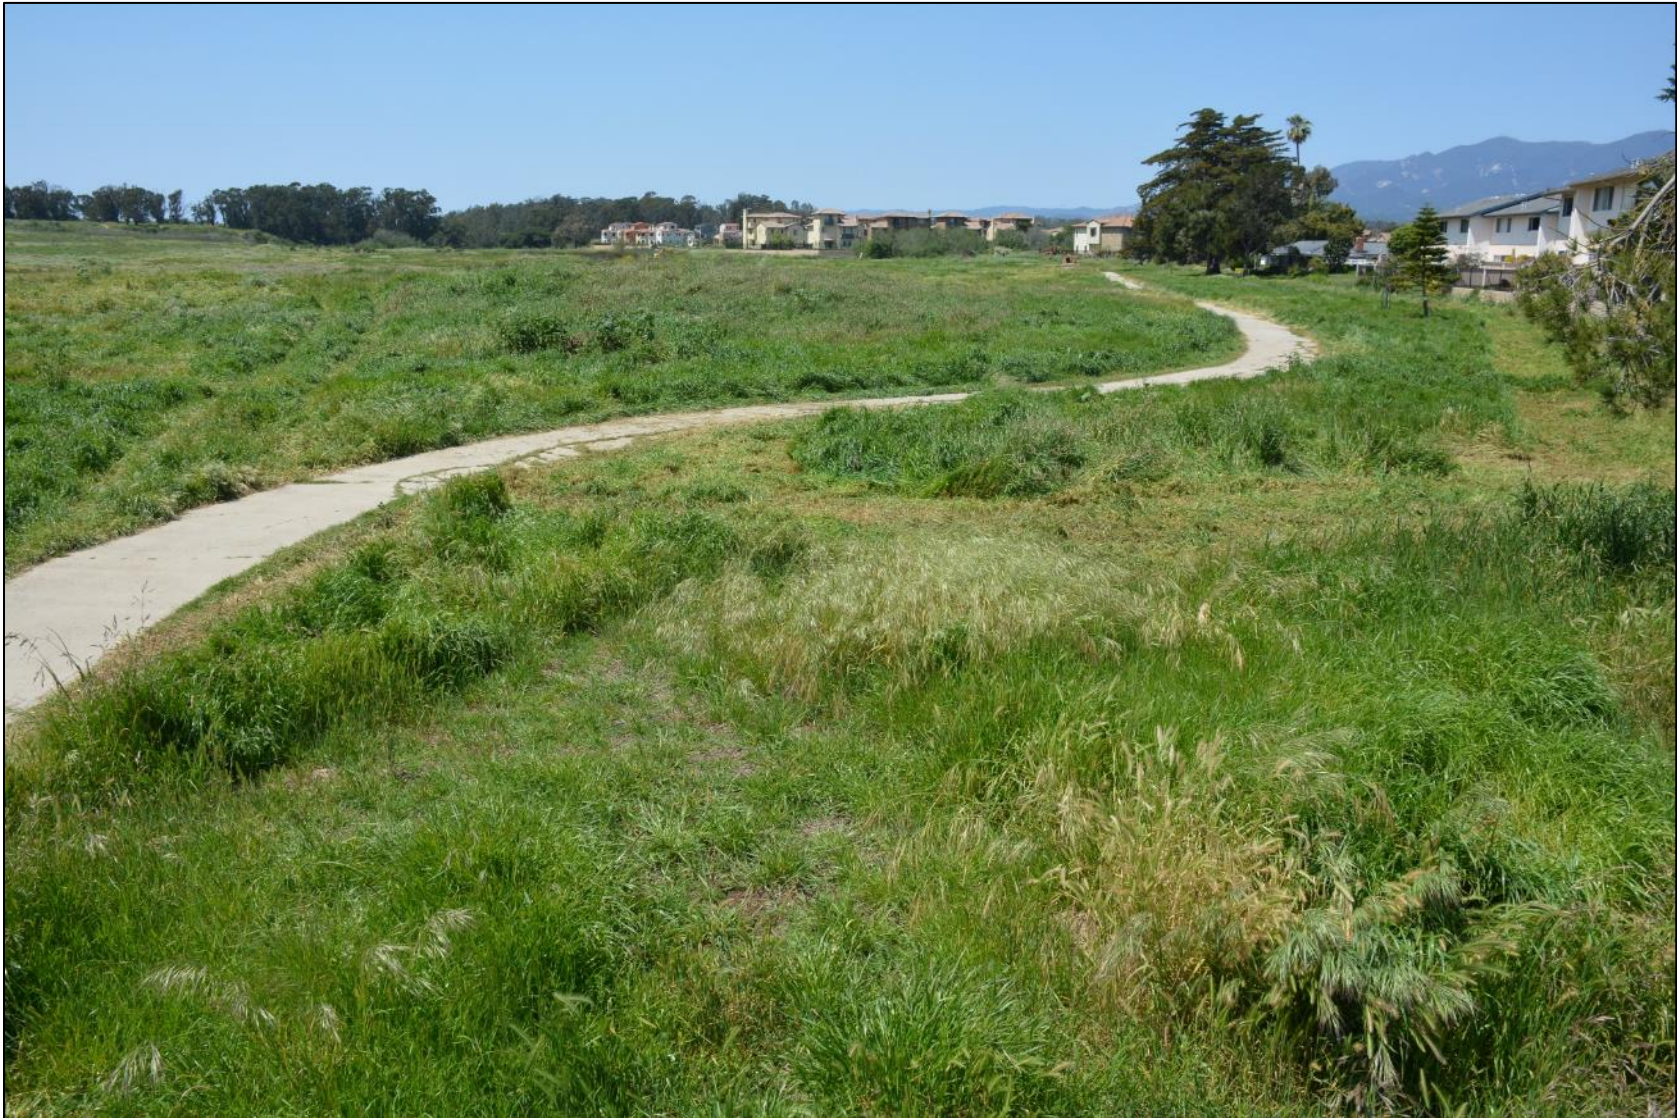
**Photo point 42-W – looking west from central point on trail along north side of NCOS project site**

**As-built photo - April 16, 2018.**

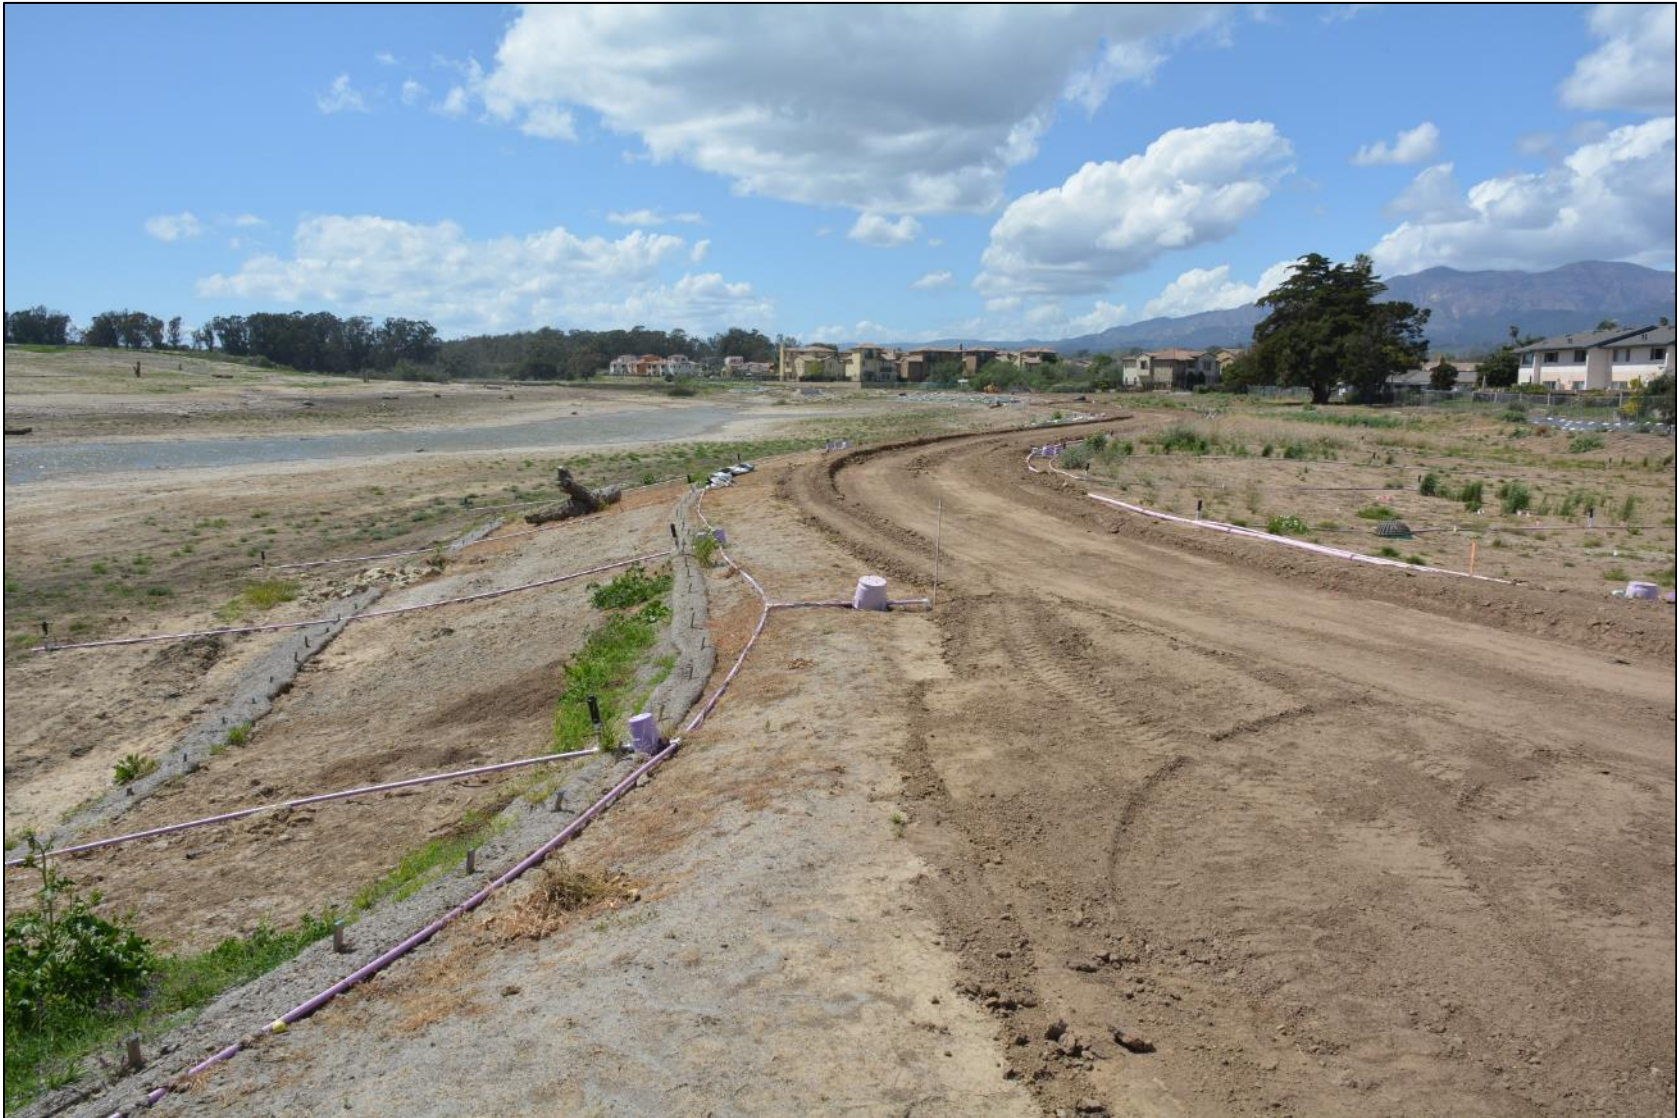
**Photo point 42-W – looking west from central point on trail along north side of NCOS project site**

**Baseline photo – pre-grading, April 10, 2017.**

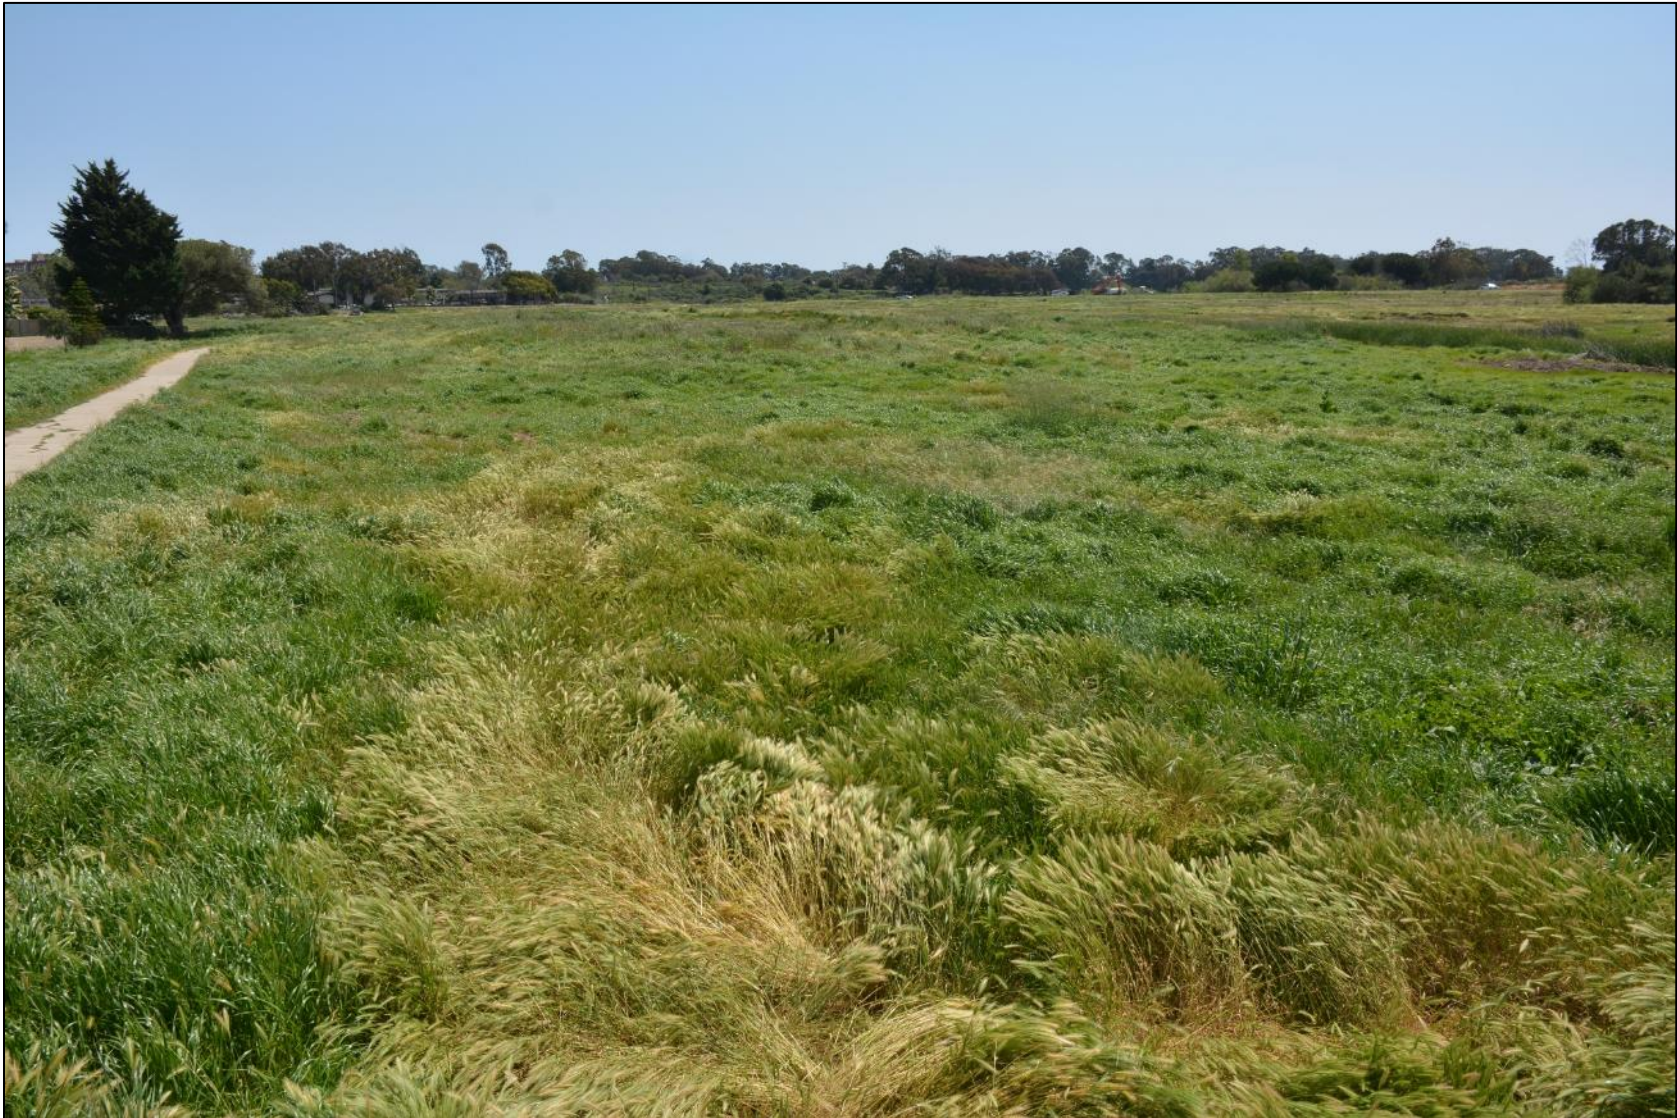
**Photo point 43-SE – looking southeast from trail along north side of NCOS project site**

**As-built photo - April 16, 2018.**

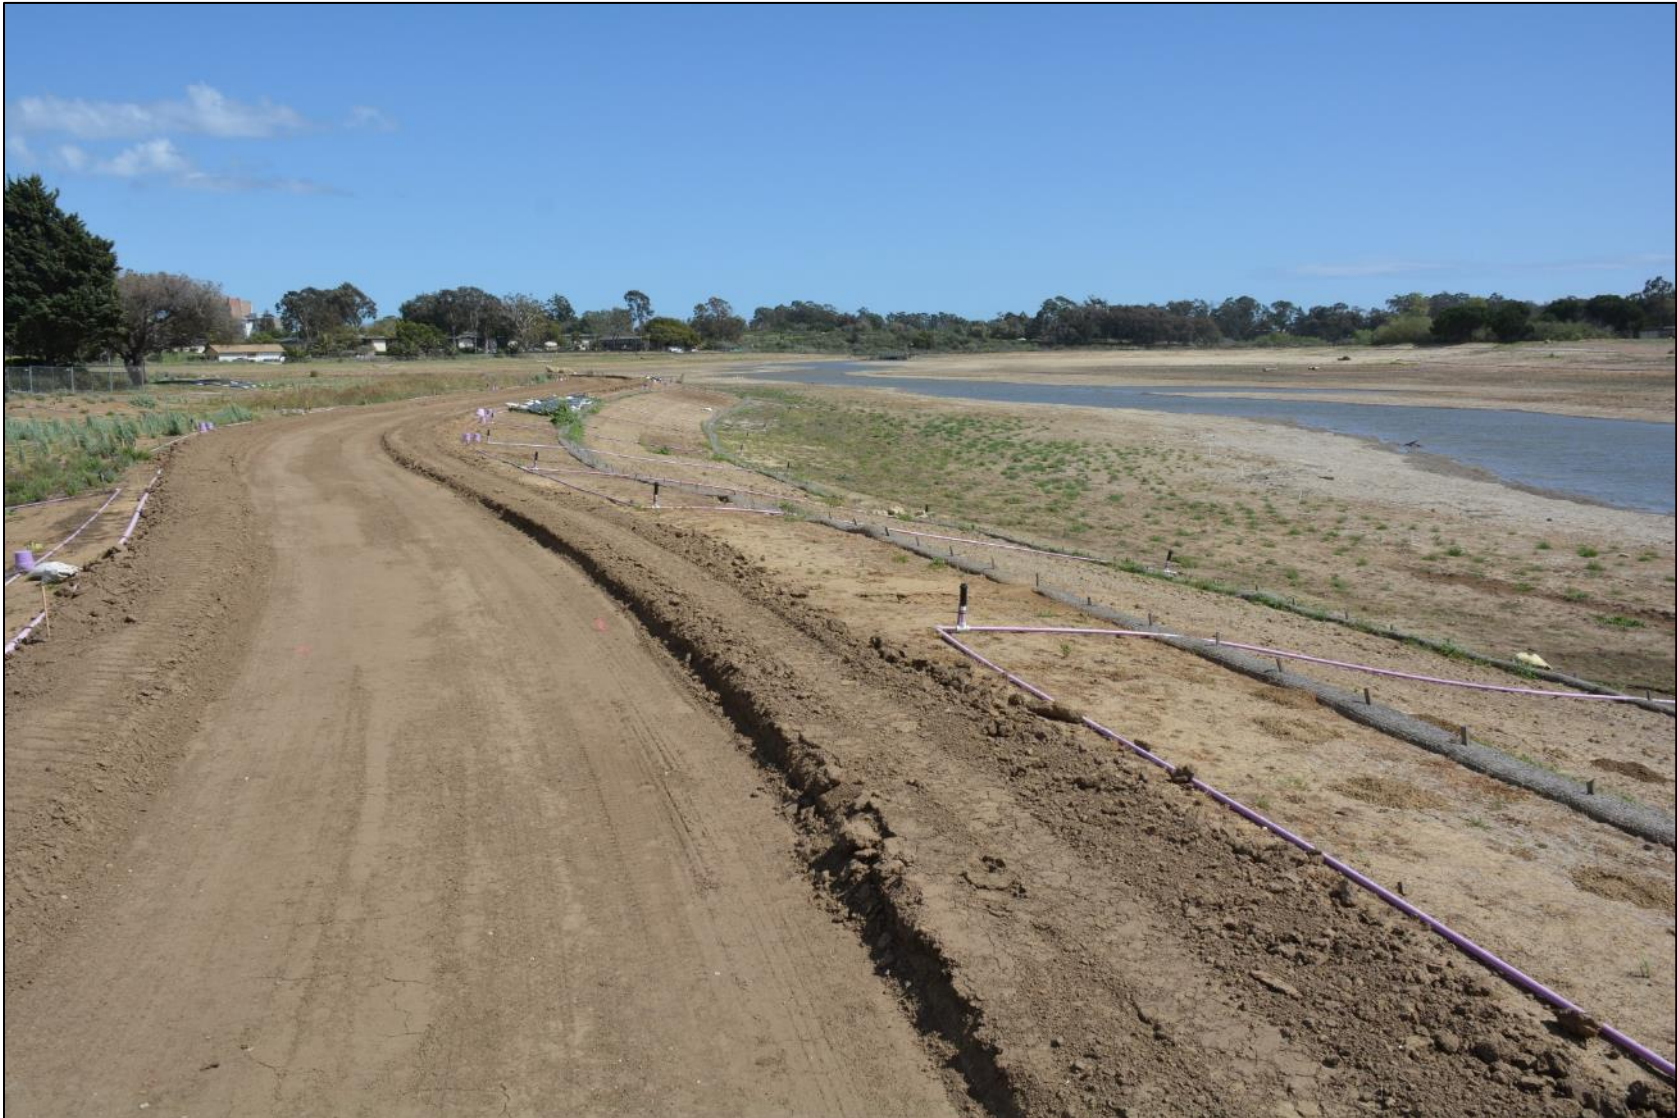
**Photo point 43-SE – looking southeast from trail along north side of NCOS project site**

**Baseline photo – pre-grading, April 10, 2017.**

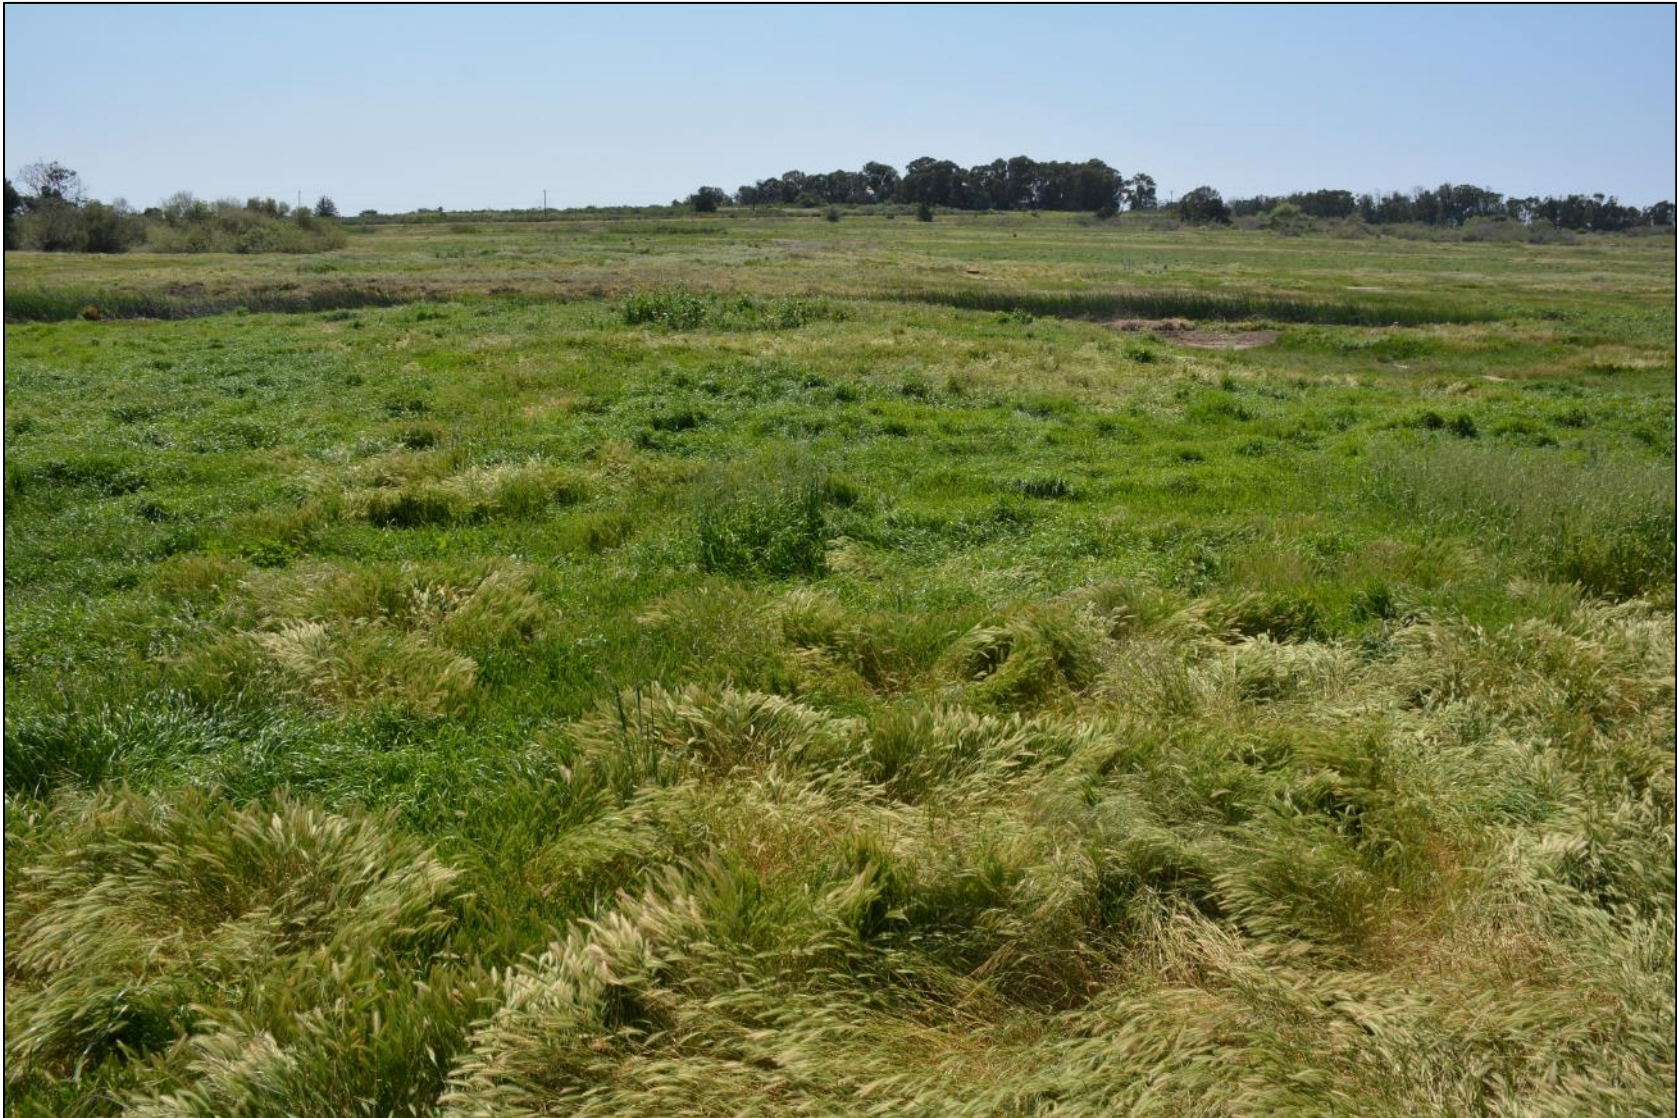
**Photo point 43-S – looking south from trail along north side of NCOS project site**

**As-built photo - April 16, 2018.**

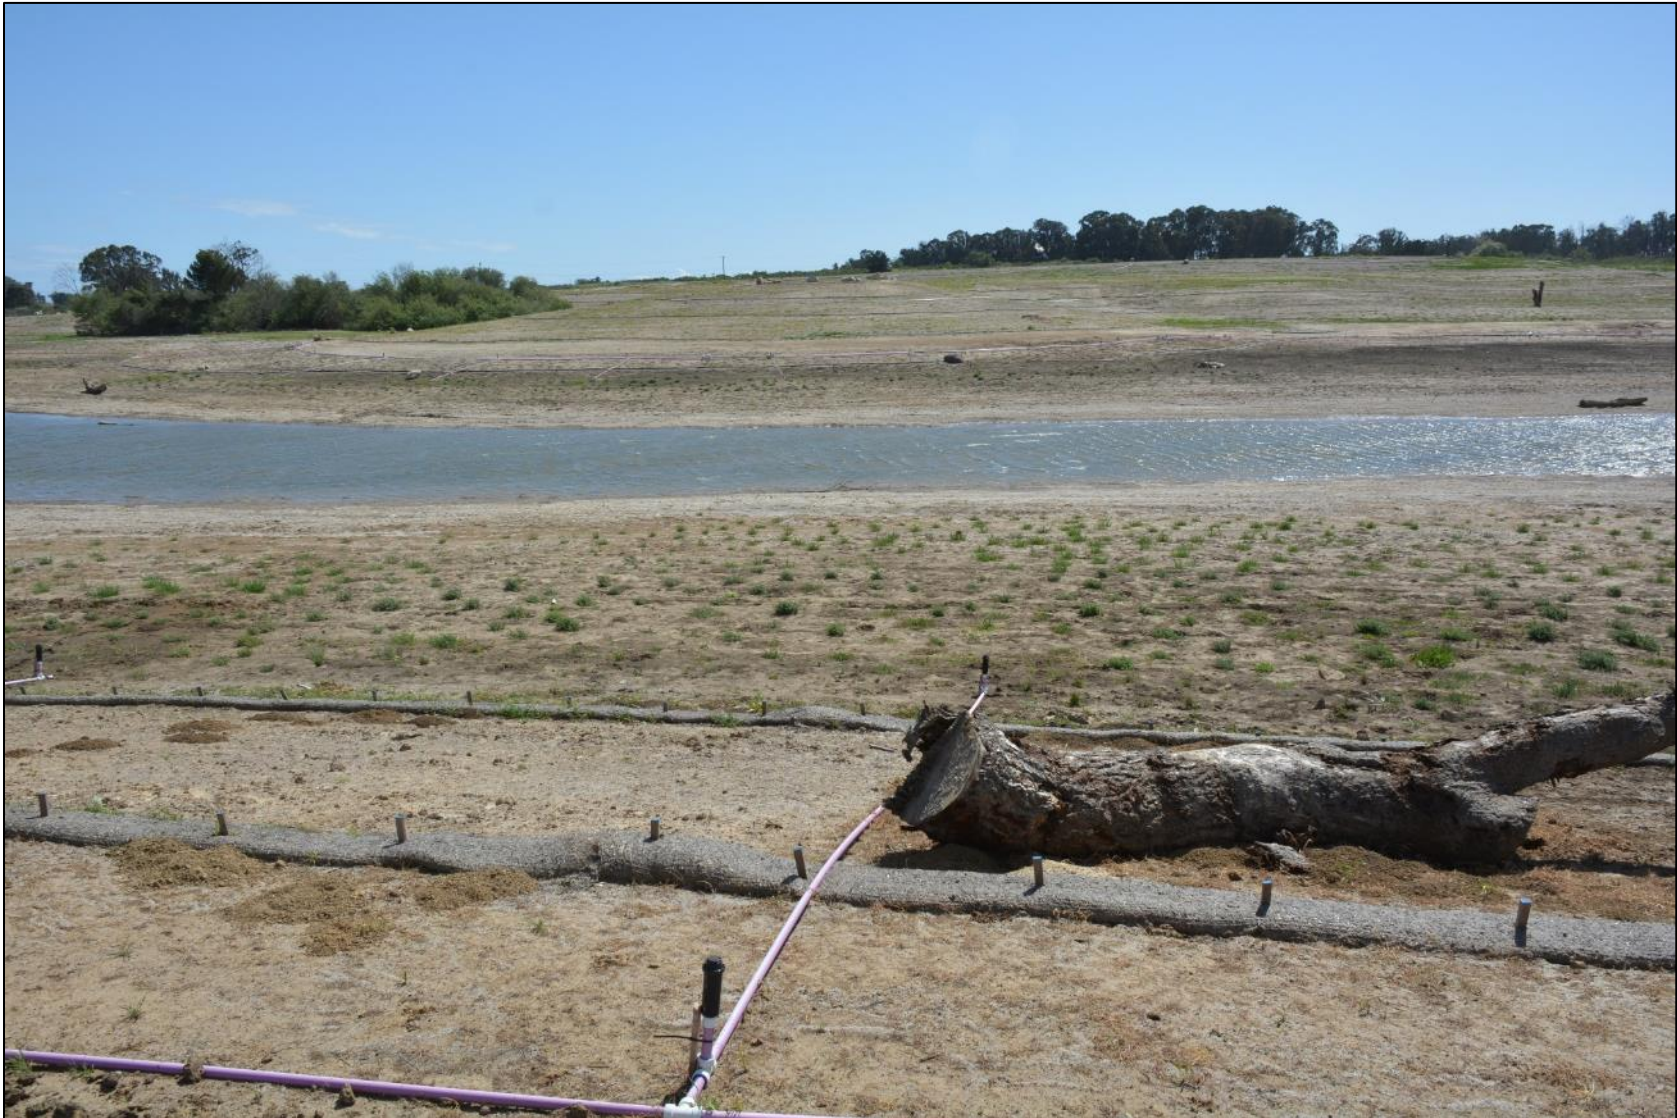
**Photo point 43-S – looking south from trail along north side of NCOS project site**

**Baseline photo – pre-grading, April 10, 2017.**
