**North Campus Open Space Restoration Project  
As-Built Grading and Hydrology Report**

**July 2018**

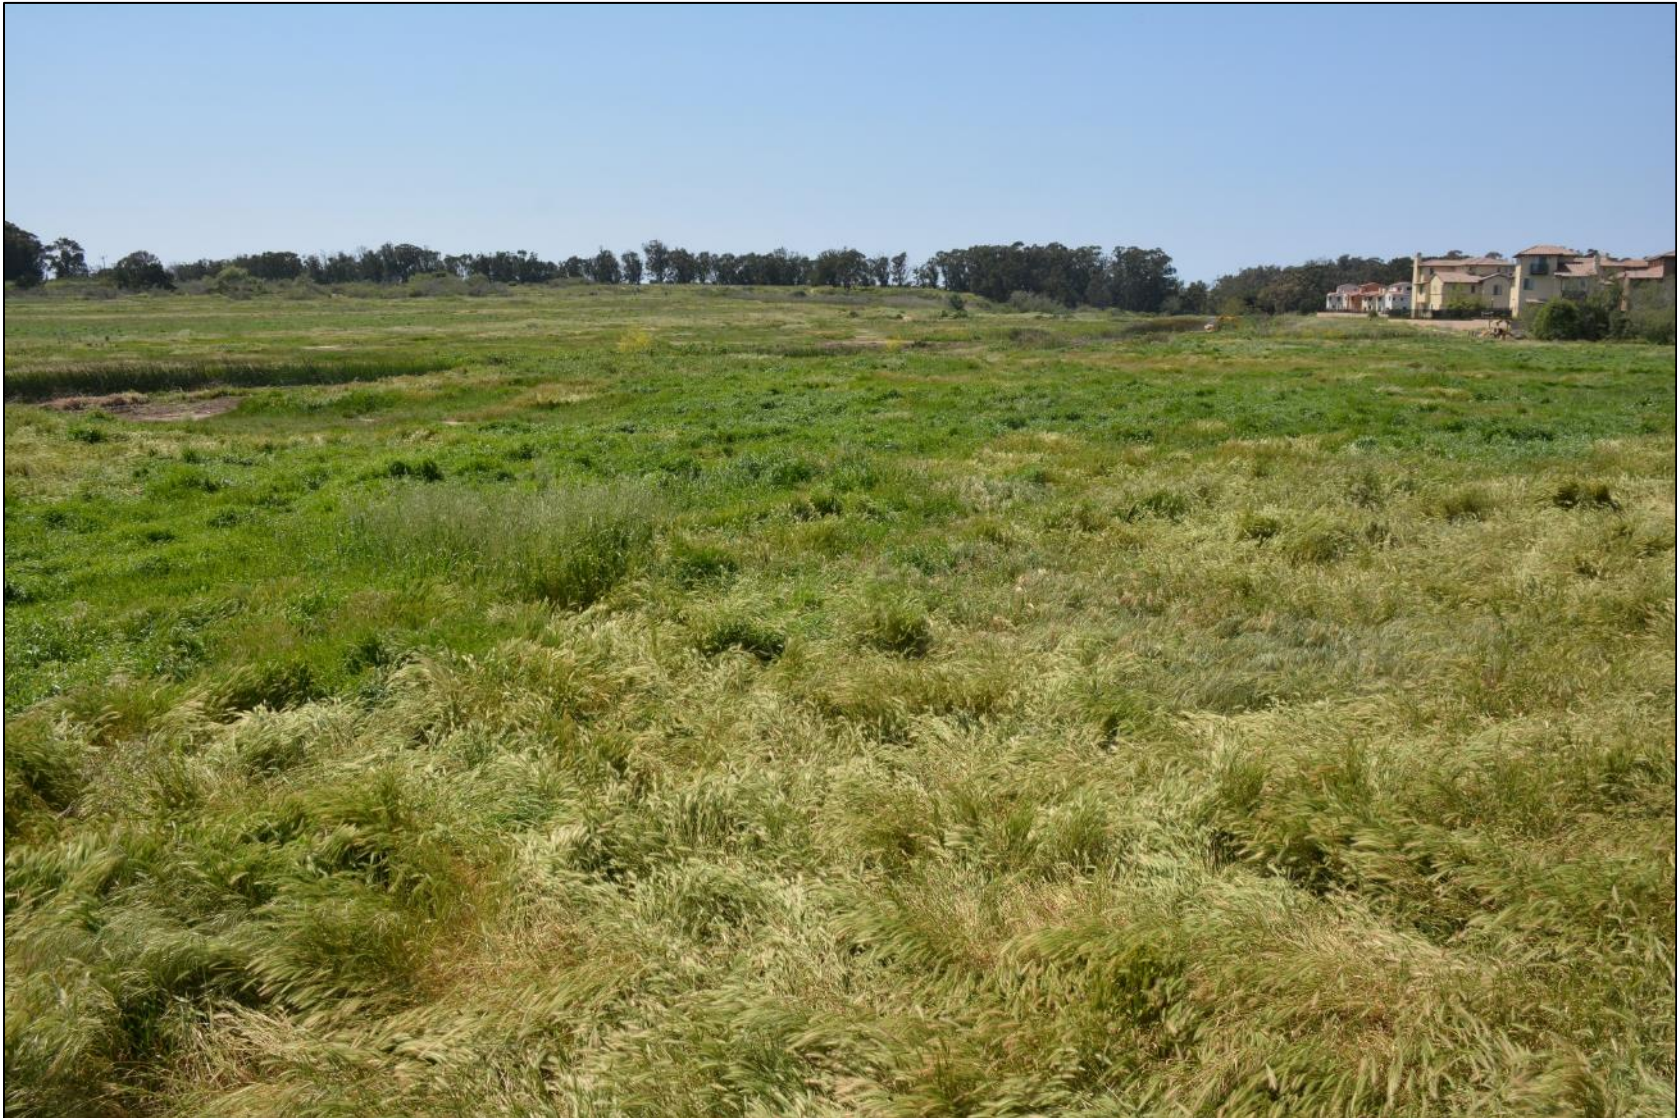
**Photo point 43-W – looking west from trail along north side of NCOS project site**

**As-built photo - April 16, 2018.**

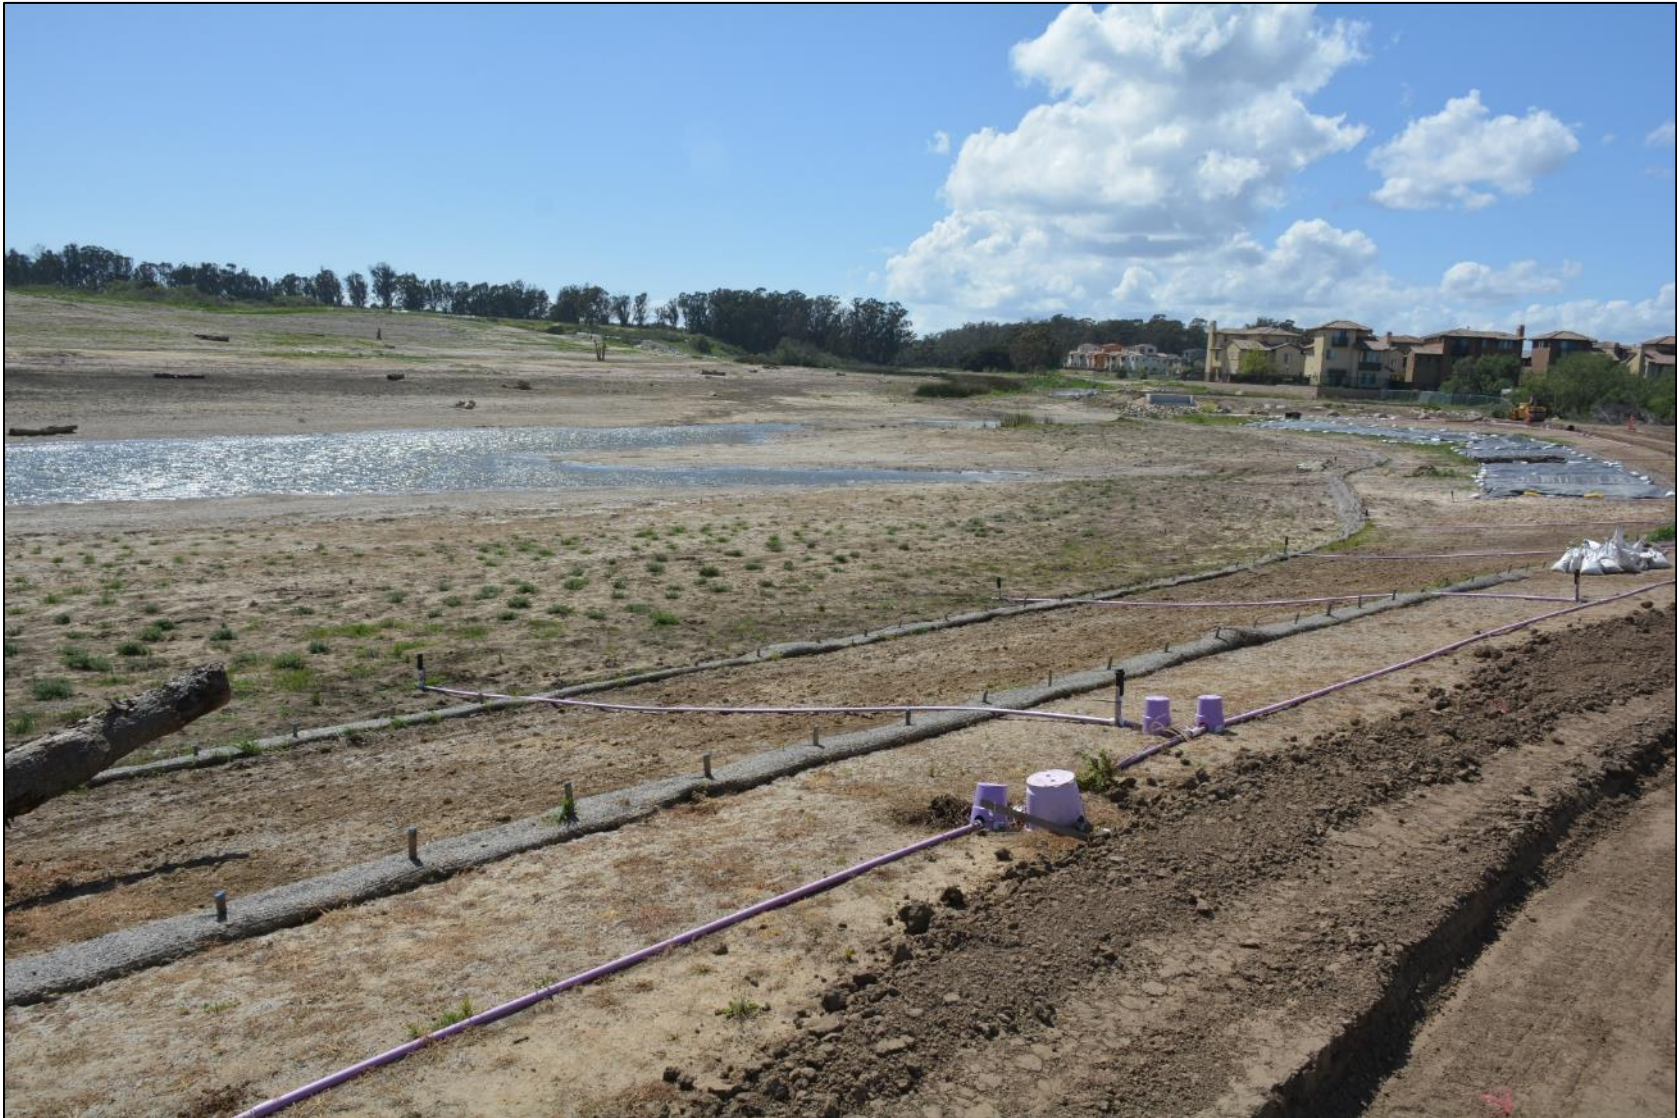
**Photo point 43-W – looking west from trail along north side of NCOS project site**

**Baseline photo – pre-grading, April 10, 2017.**
